Examination and Conservation Treatment Report

X House Entrance Leadlight Casements

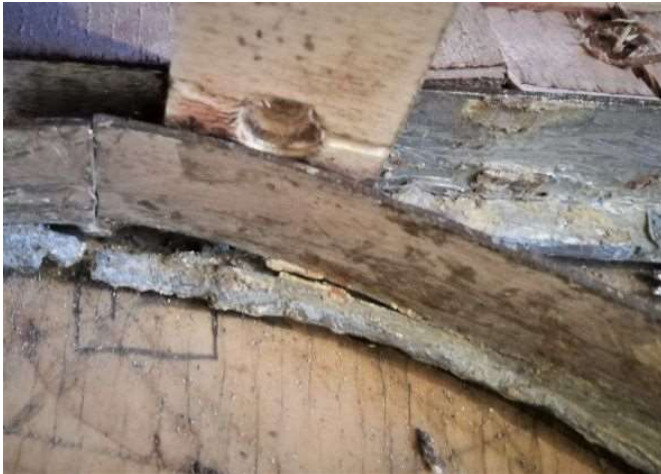
Fig.13 - Silver coloured metal coating, Casement 1

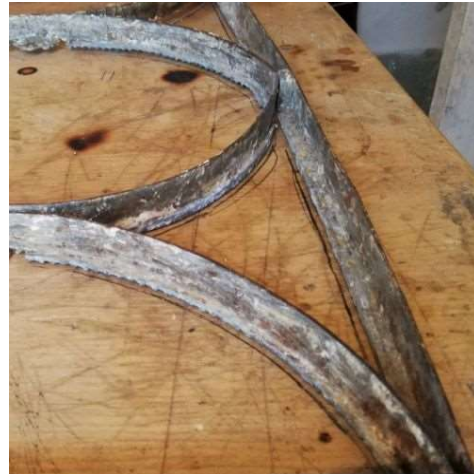
Fig.14 - Patches of orange corrosion, Casement 1

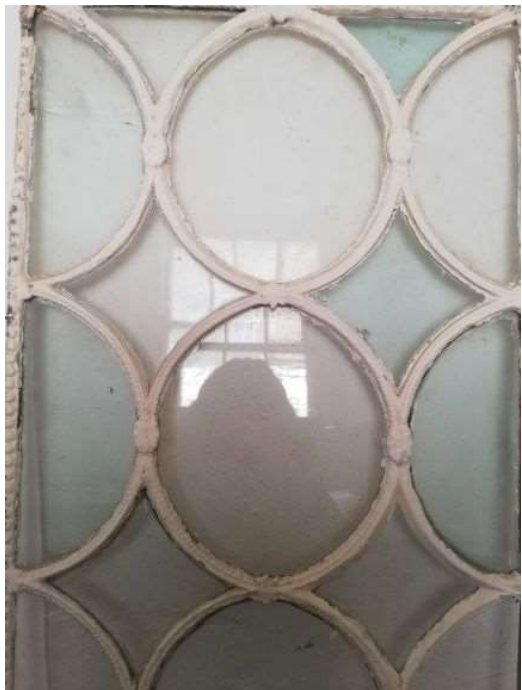
Fig.17 – Different hues of clear glass, C1

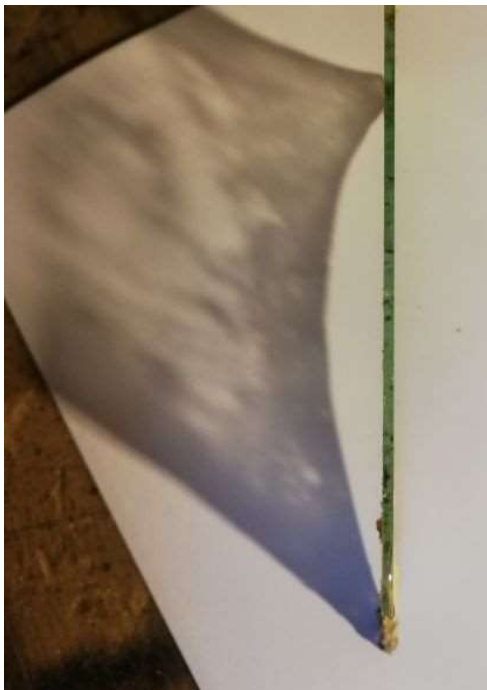
Fig.18 – Curved striations visible in reflection, C2

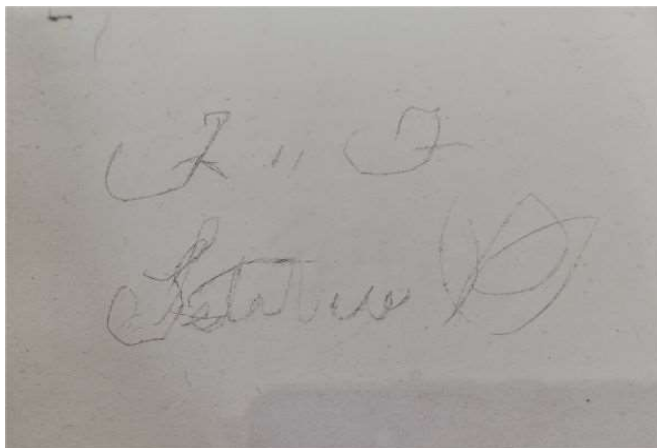
Fig.19 – Graffiti scratched into glass pane, Casement 2

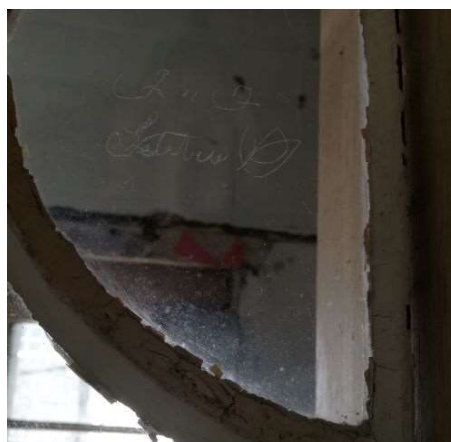
Fig.20 – Graffiti scratched into pane, Casement 2

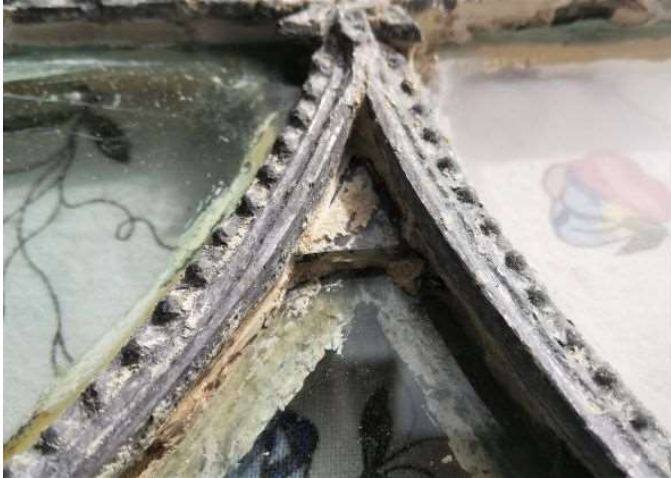
Fig.21 – Fragments of previous repairs remain in corners, C2

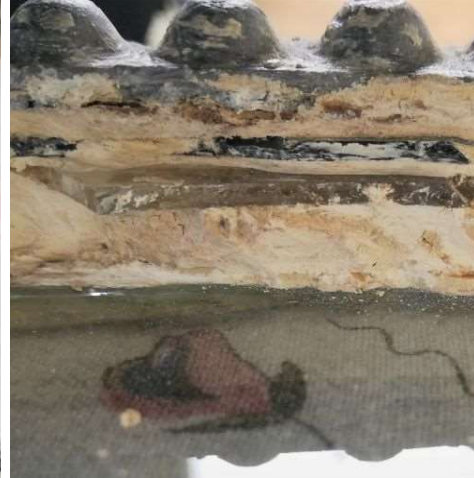
Fig.22 – Differing depths of bedding putty, C2

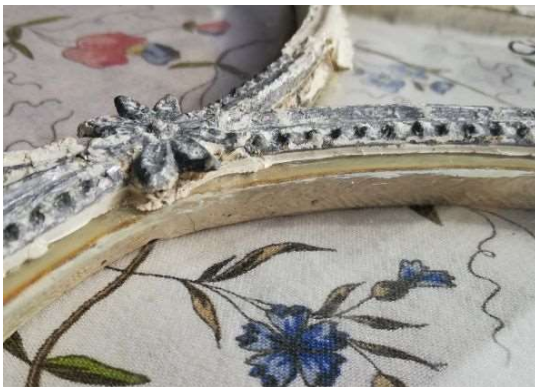
Fig.23 – Varying depths of putty, thin, Casement 2

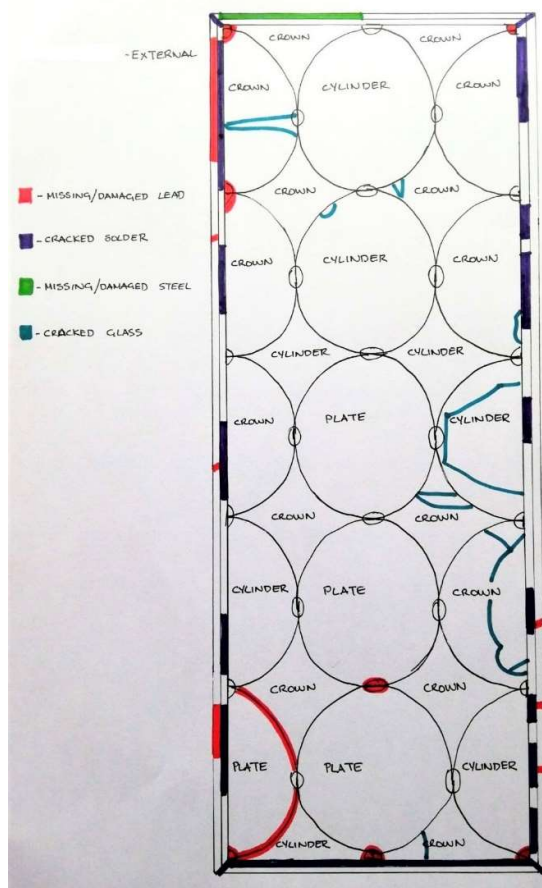
Fig.27 - Condition survey of Casement 1 (May 2019)

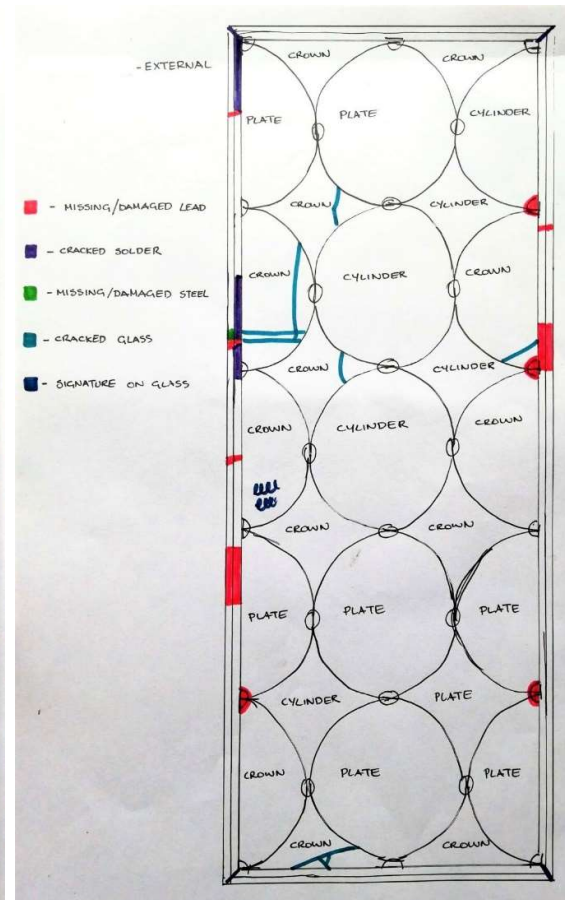
Fig.28 – Condition survey of Casement 2 (May 2019)

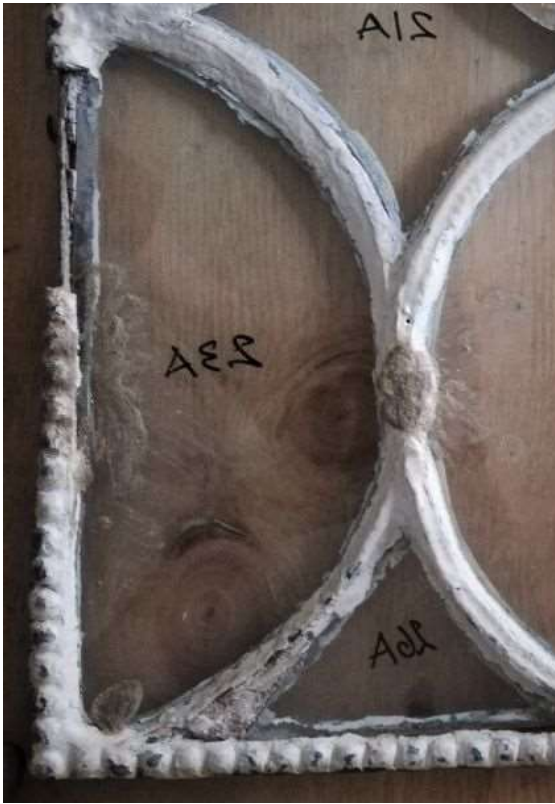
Fig.29 – Missing lead carelessly puttied over, Casement 1

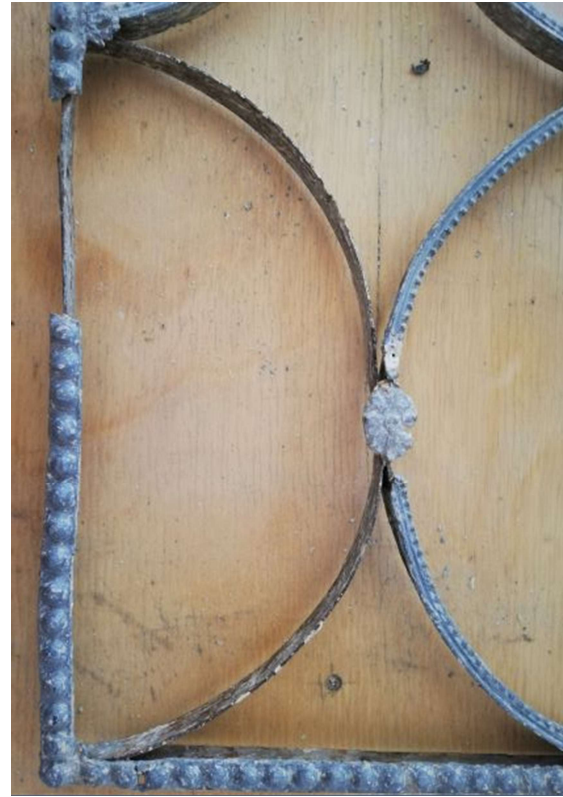
Fig.30 – Full extent of decorative lead loss evident, C1

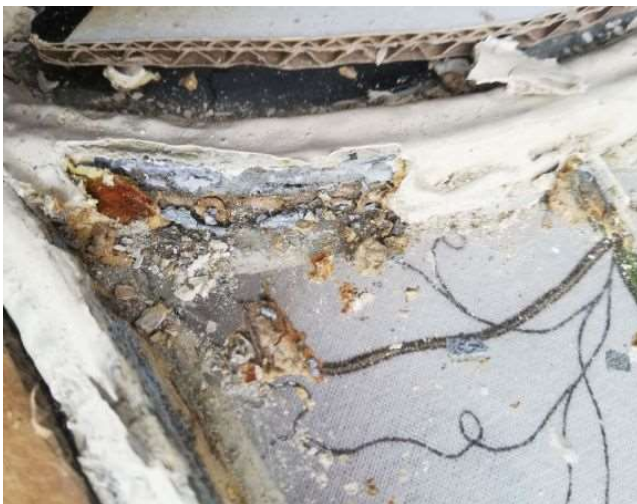
Fig.31 - Friable corroded lead discovered beneath paint, C2

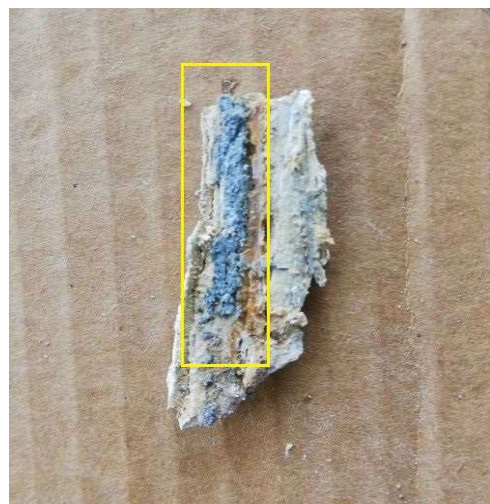
Fig.32 -Lead corrosion adhered to detached putty, C2

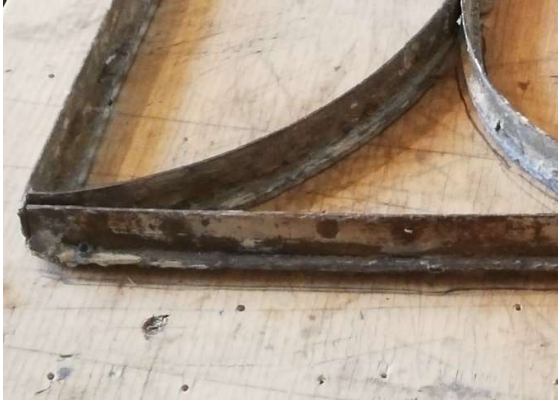
Fig.33 - Corrosion of base metal, Casement 1

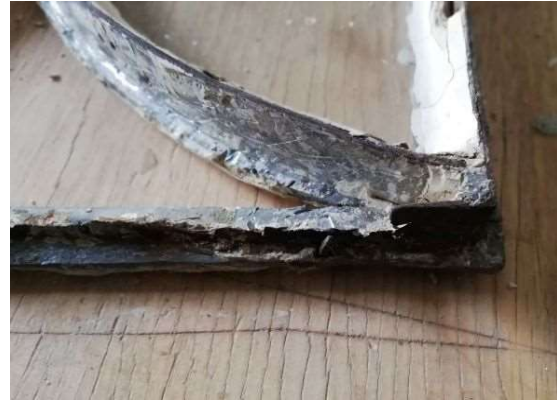
Fig.34 - Severe corrosion of bar has led to disintegration, C1

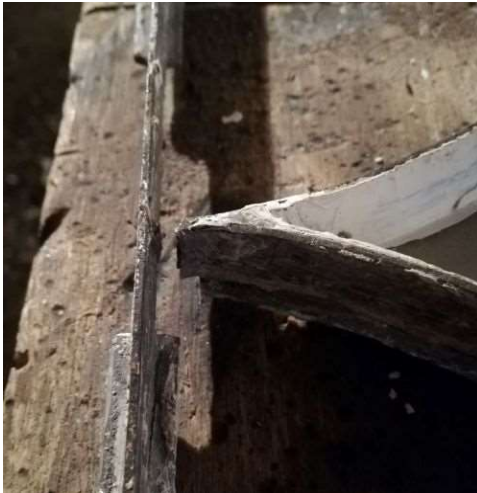
Fig.35 - Cracked and loose joints on Casement 2

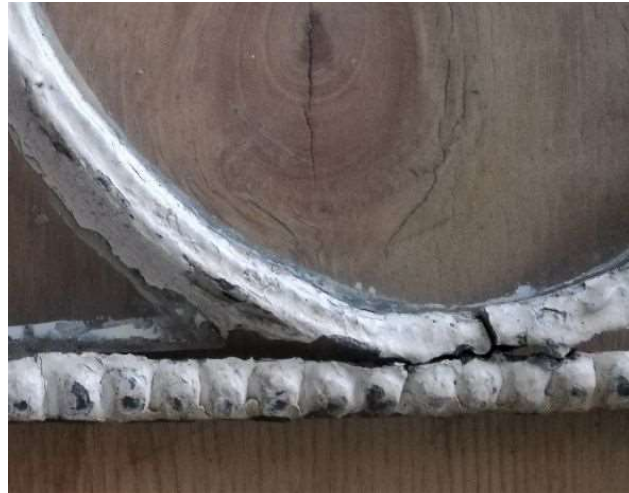
Fig.36 – Cracked joint, Casement 1.

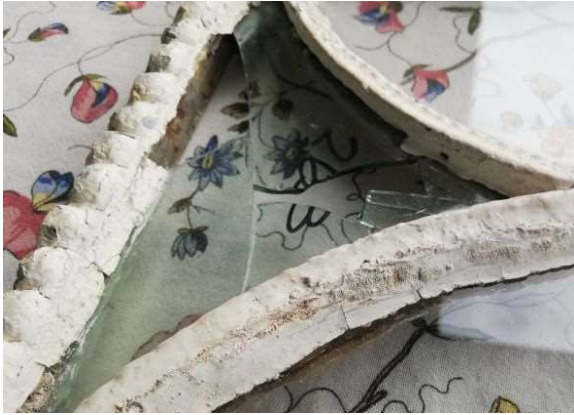
Fig.37 – Shatter pane, Casement 2

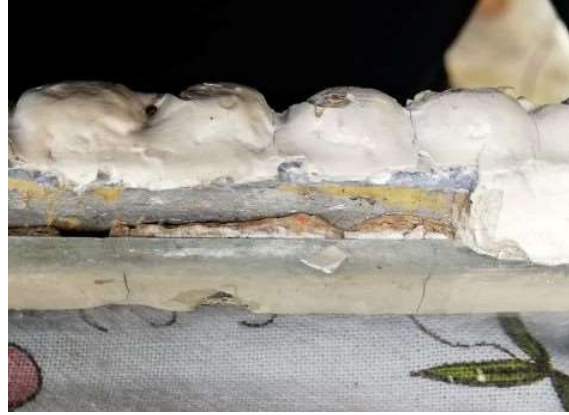
Fig.38 – Missing putty, Casement 2

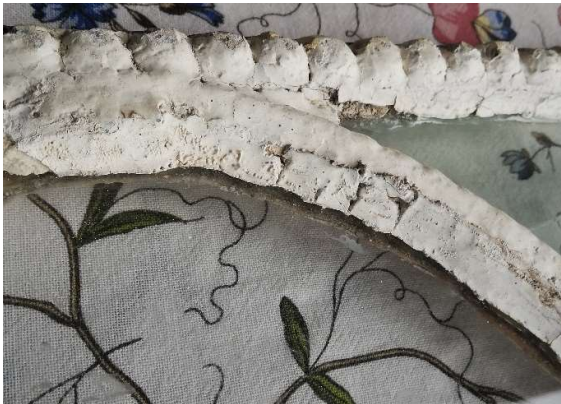
Fig.39 – Excessive and careless application of putty, C2

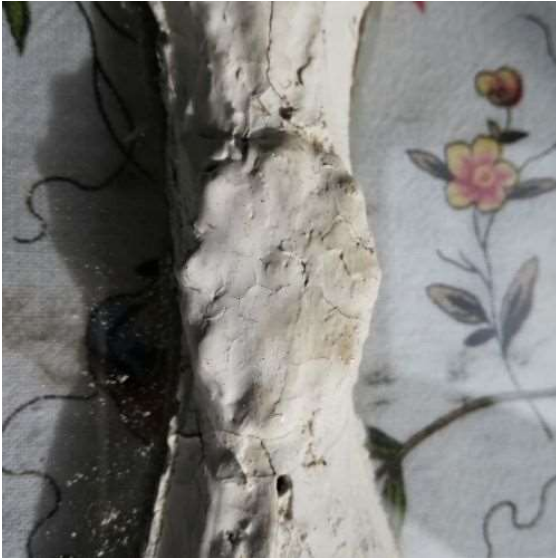
Fig.41 – Paint obscuring decorative flower, Casement 2

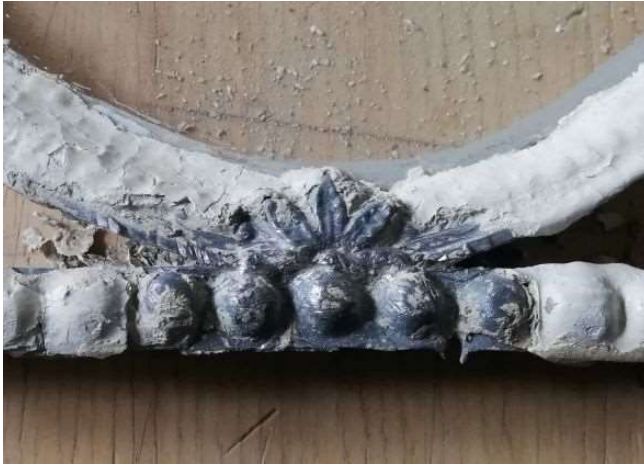
Fig.43 – Removal of paint using UV heat gun detail, Casement1

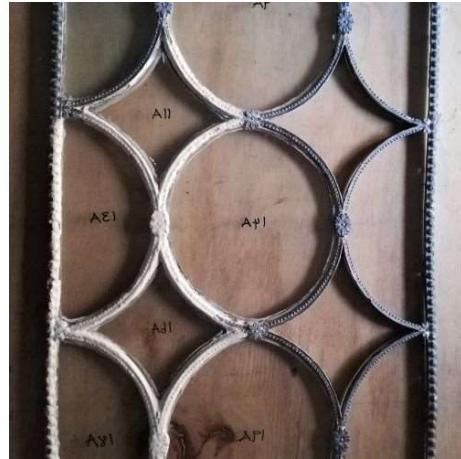
Fig.44 – Removal of paint using UV heat gun, C1

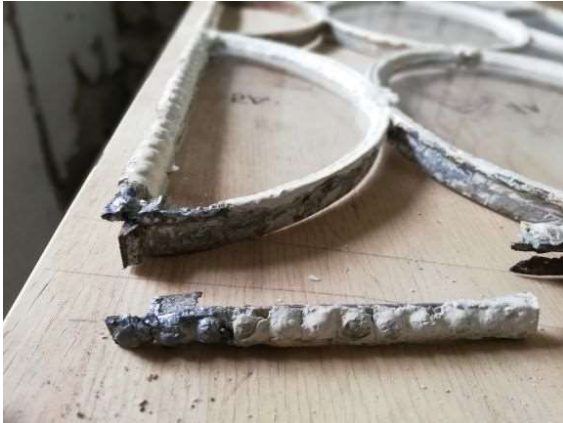
Fig.45 – Corroded flat bar and lead detached, C1

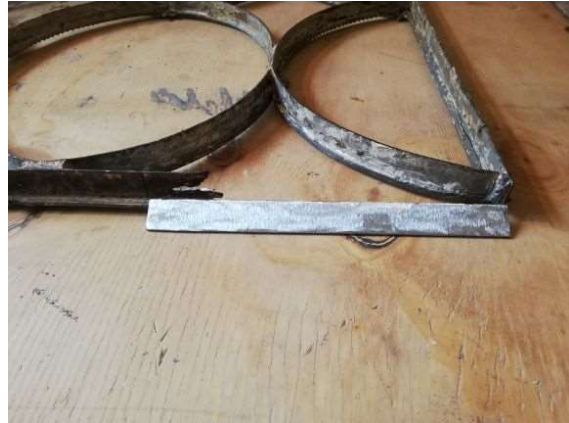
Fig.46 – Replacement 2mm rolled steel cut to size, C1

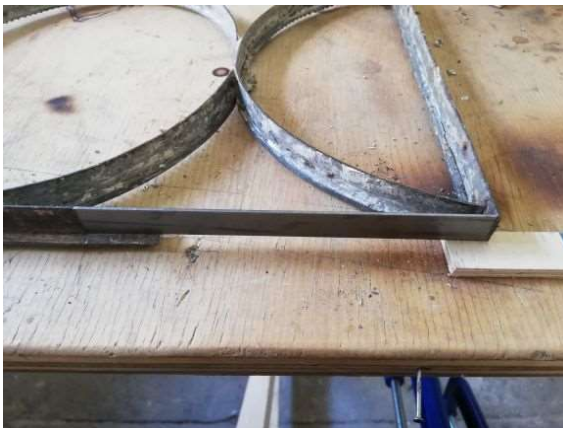
Fig.47 – Corroded iron cut back and new metal cut to fit, C1

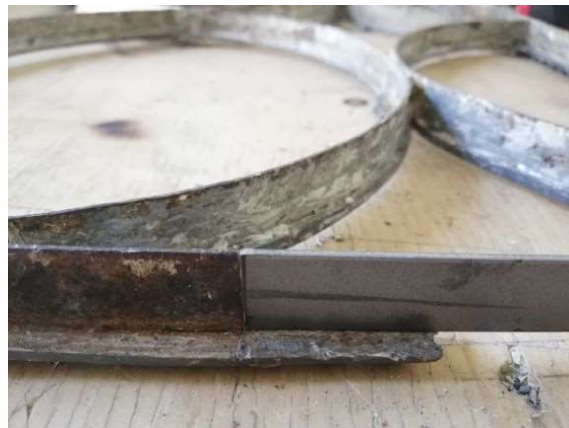
Fig.48 – Smooth join between new metal and original, C1

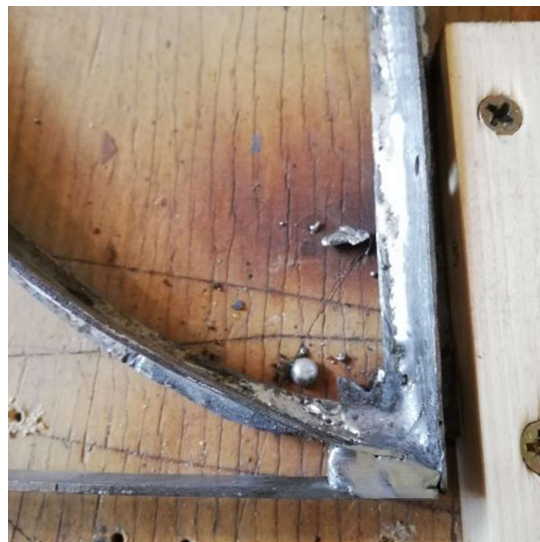
Fig.50 – New solder block and joint to fix replacement metal, C1

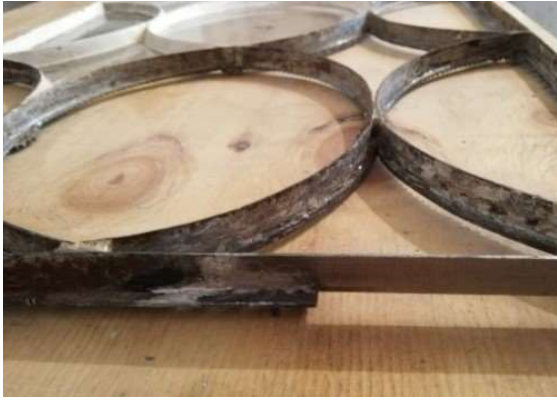
Fig.51 – New solder joints, C1

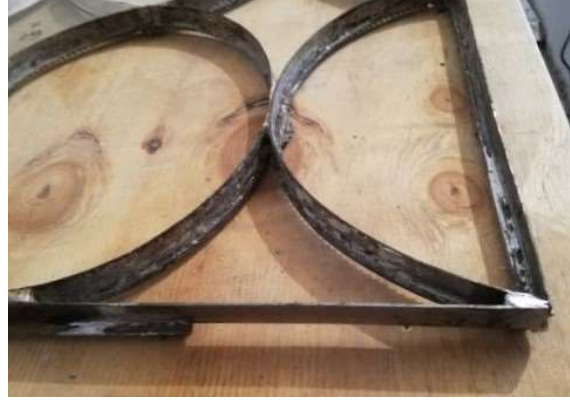
Fig.52 – Replacement metal soldered into position, C1

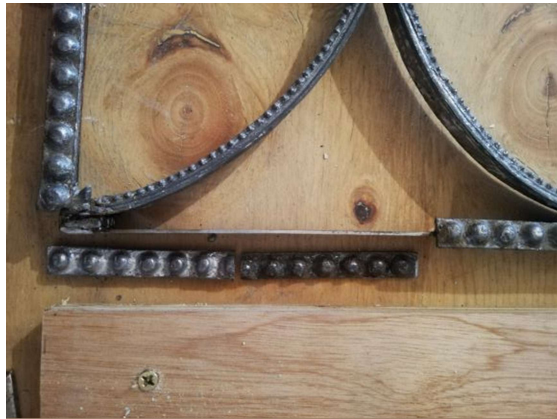
Fig.53 – Leadwork was trimmed and refit over area of loss

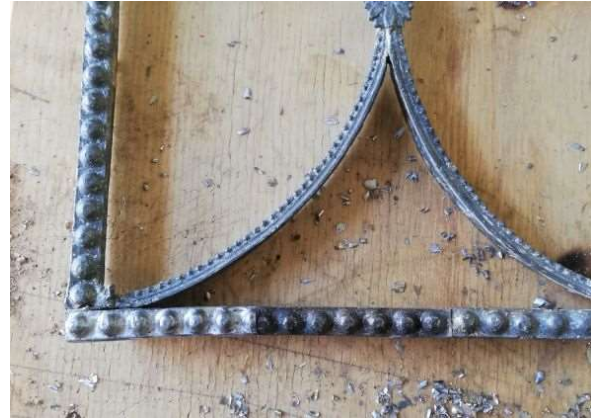
Fig.54 – Leadwork soldered into position, C1

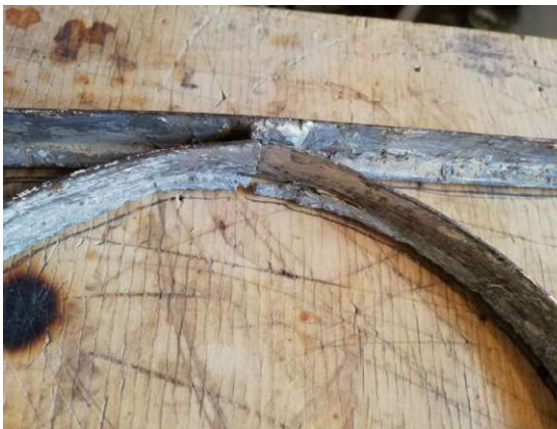
Fig.55 – Cracked solder joint and block, Casement 1

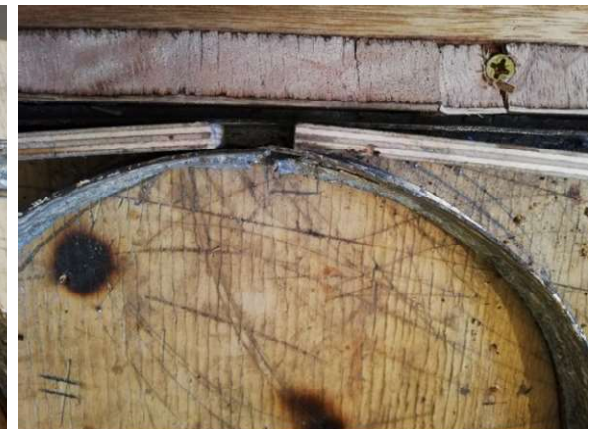
Fig.56 – Preparation for new solder block, Casement 1

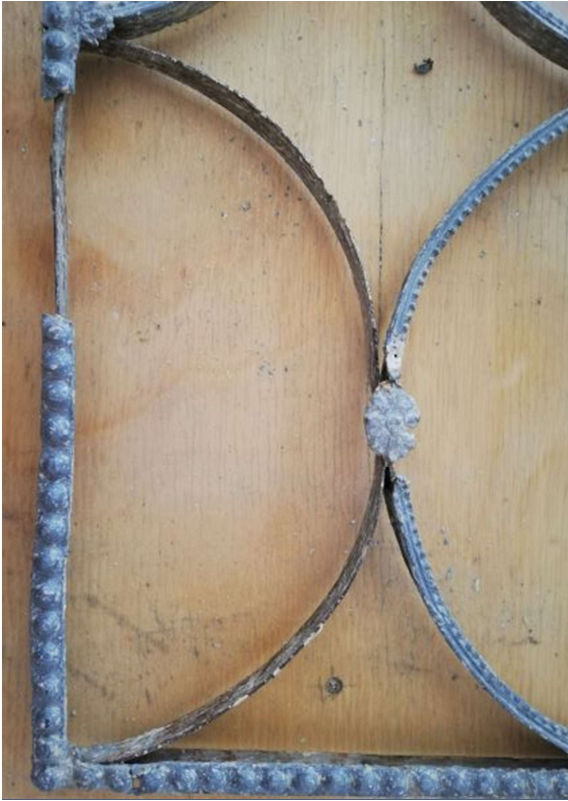
Fig.63 – Missing leadwork sections, Casement 1

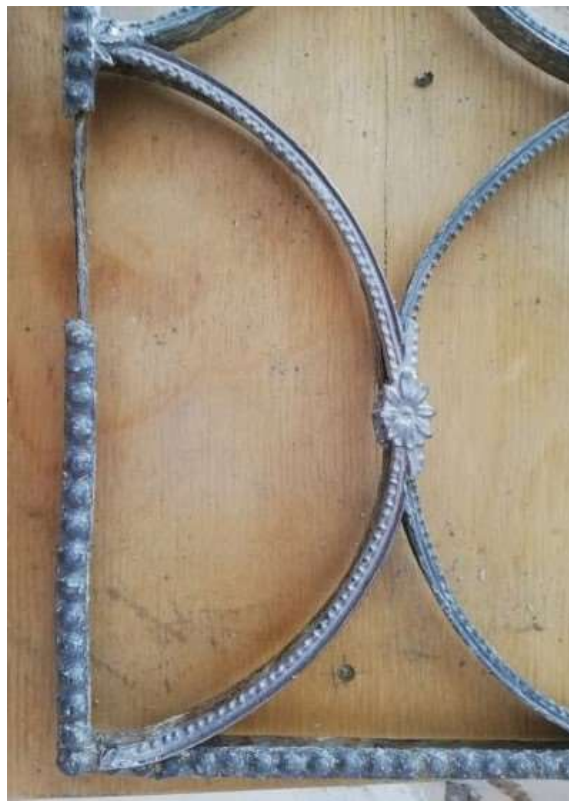
Fig.64 – Replacement decorative lead, Casement 1

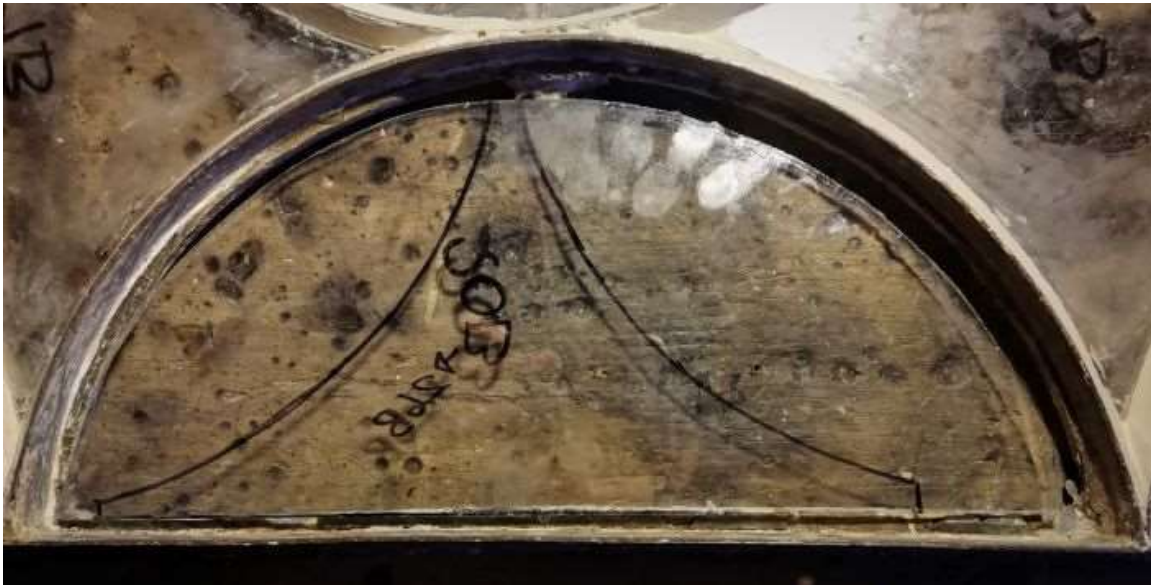
Fig.65 – Original glass that no longer fits within frame to be reused elsewhere, Casement 2

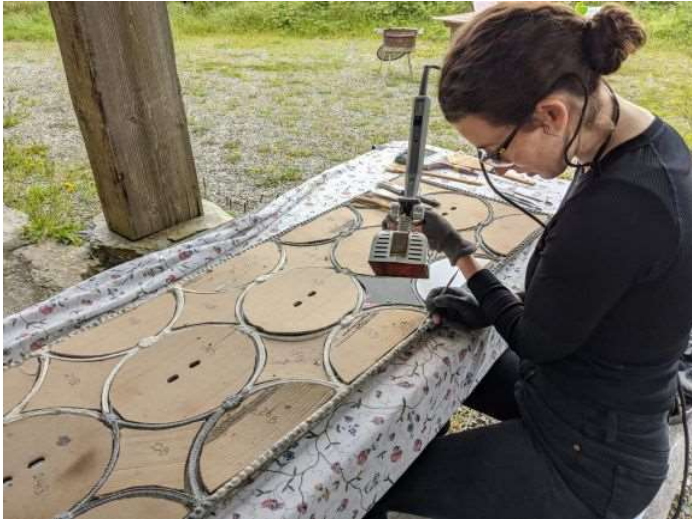
Fig.67 – Paint removed using UV heat gun and dental tools, Casement 2

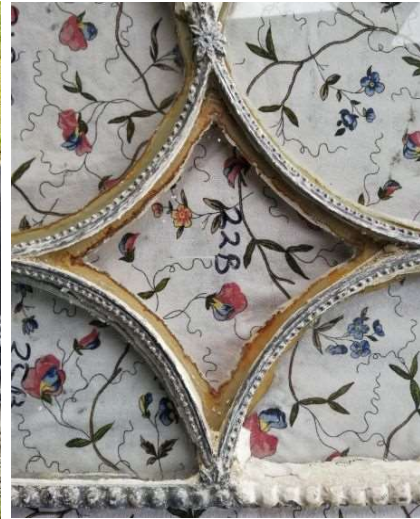
Fig.68 – Paint removal, Casement 2

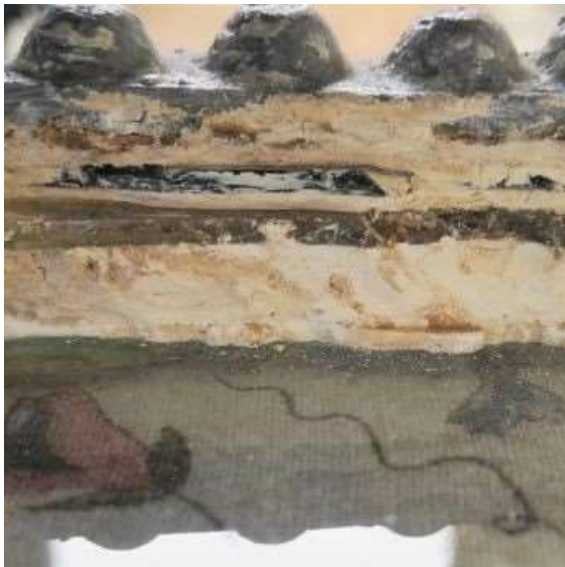
Fig.69 – Evidence of previous glass types in putty, C2

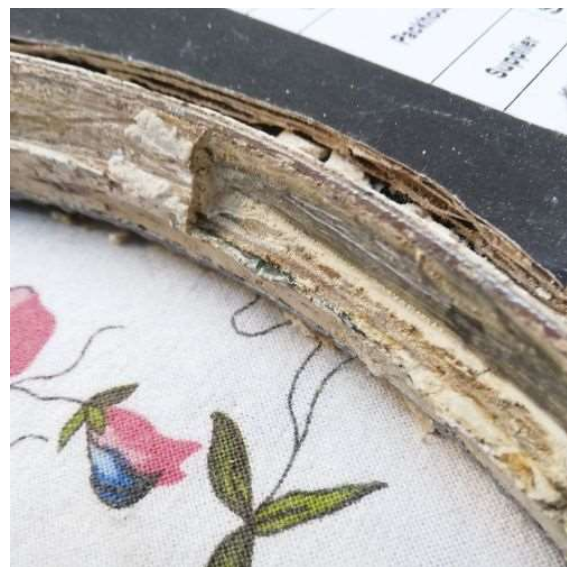
Fig.70 – Retaining variety of depth in bedding putty, C2

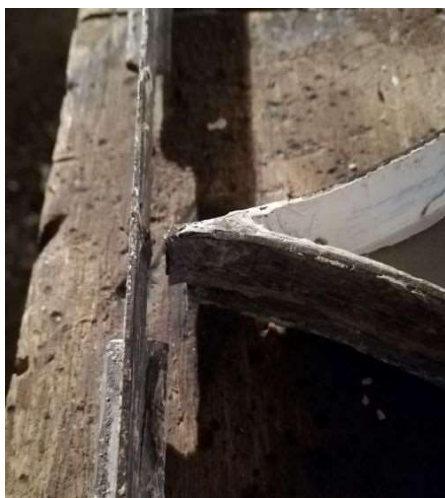
Fig.71 – Loose joint, Casement 2

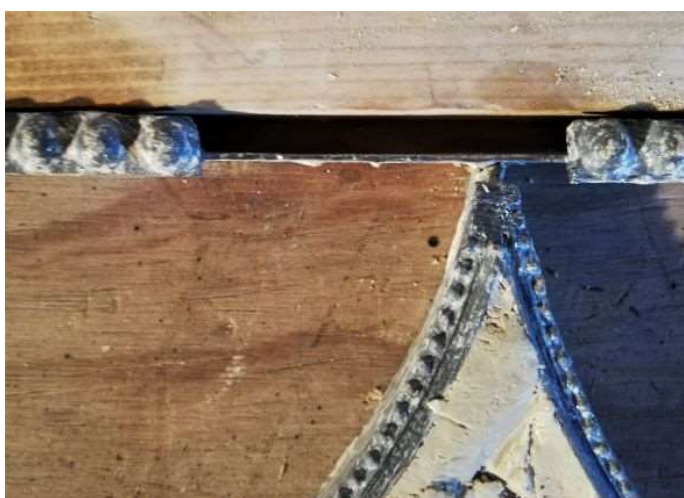
Fig.72 – Missing leadwork about loose joint, C2

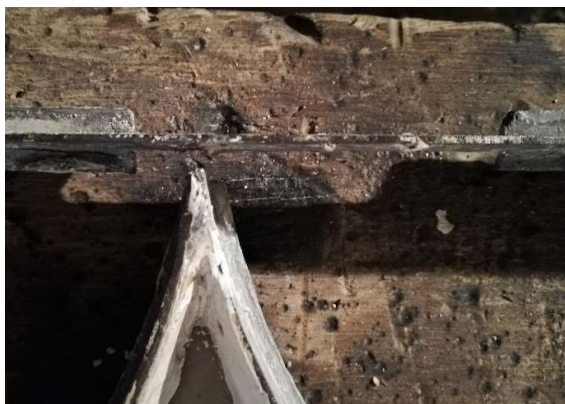
Fig.73 – Cracked and loose joint, C2

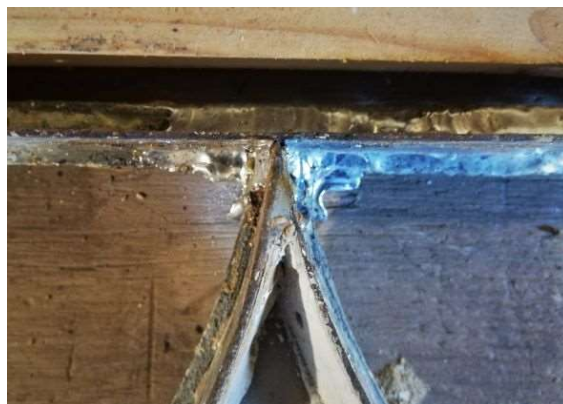
Fig.74 – New solder joint, C2

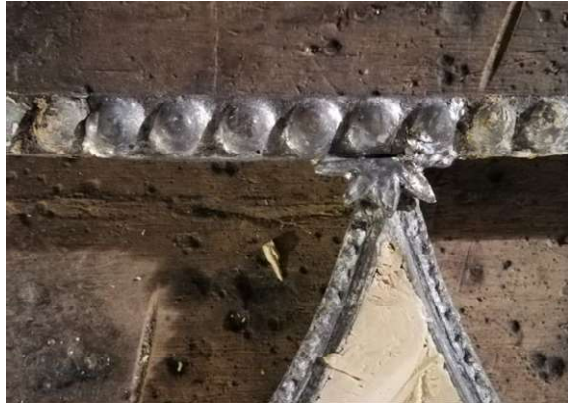
Fig.76 – Cast lead replacements in place, C2

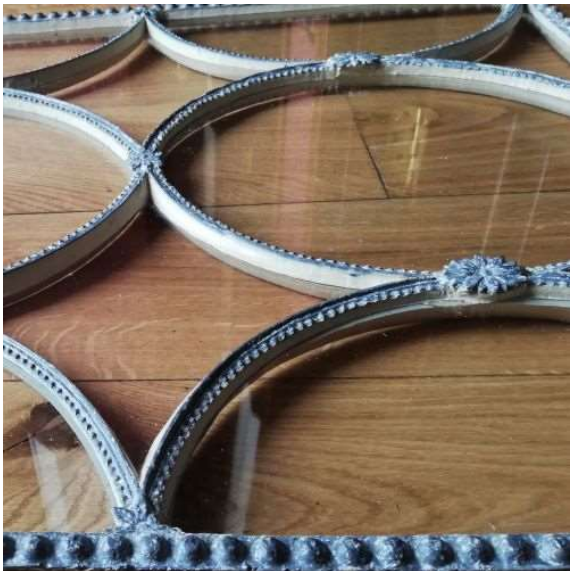
Fig.77 – Putty glazing on the front, Casement 2

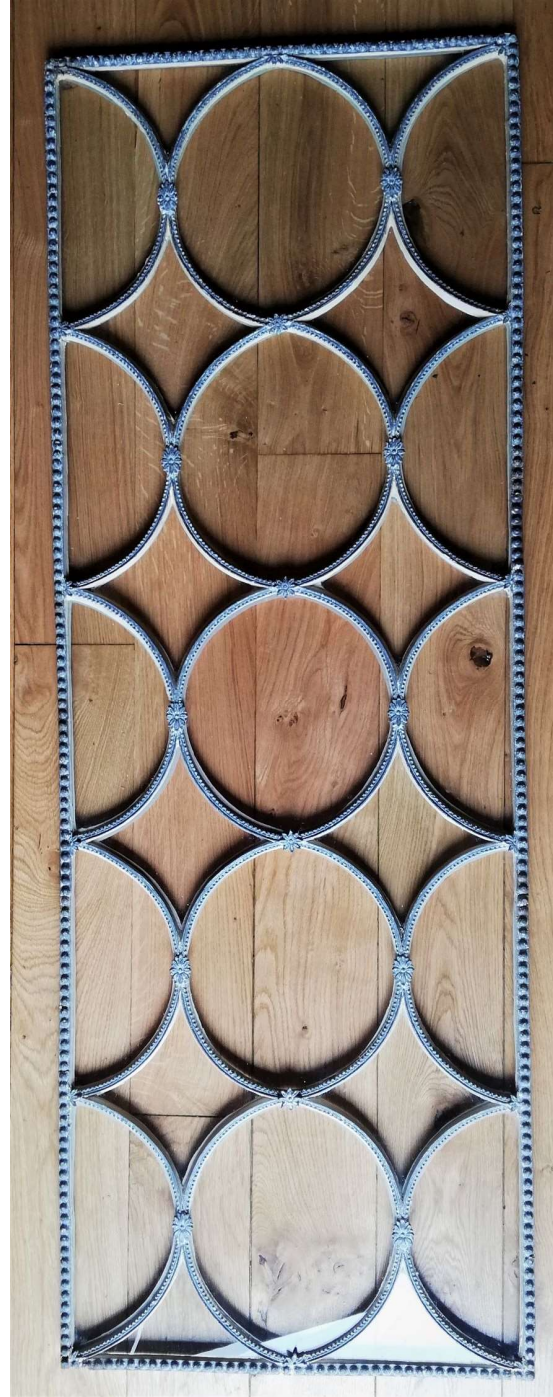
Fig.80 - Casement 2 (June 2020)

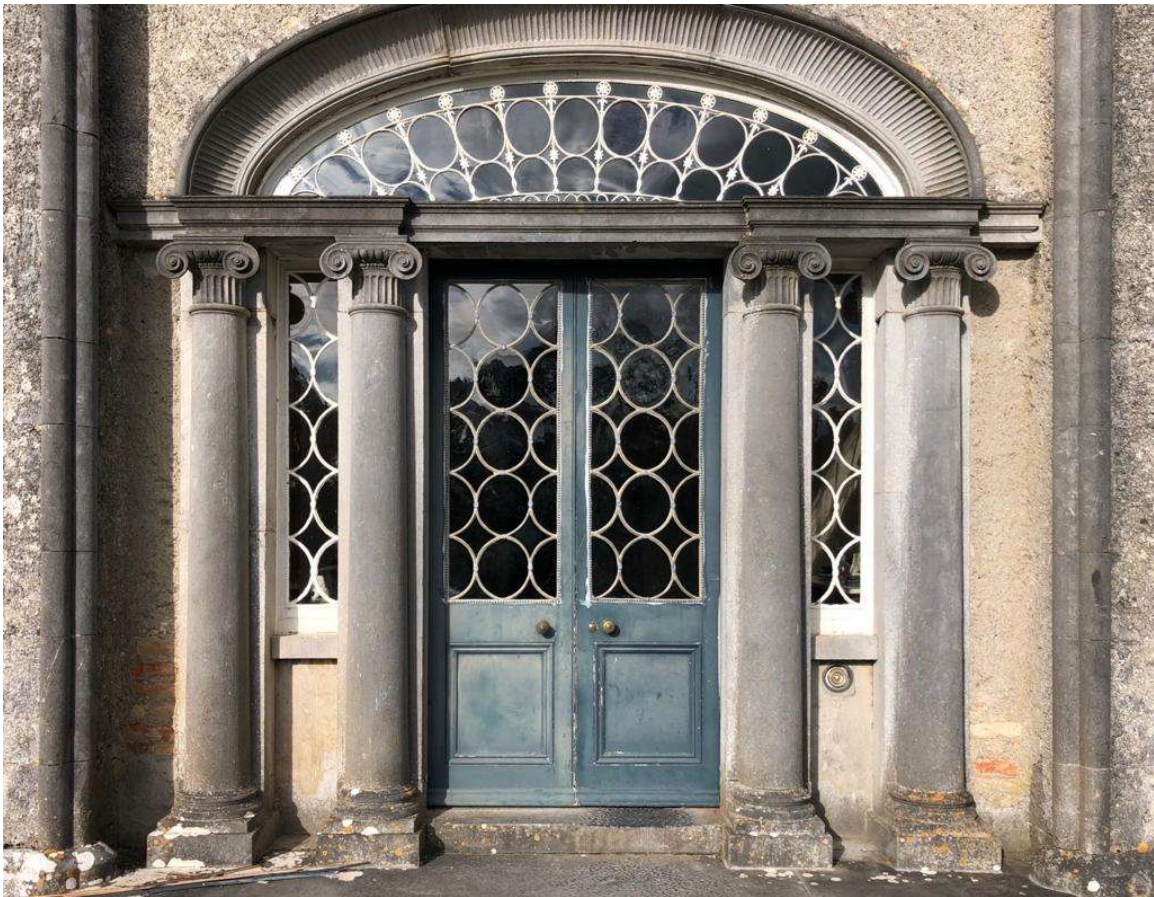
Fig.81 – Casements reinstalled in the entrance doors, 2020
