# Building and Collection Survey

Leicestershire Church

November 2019

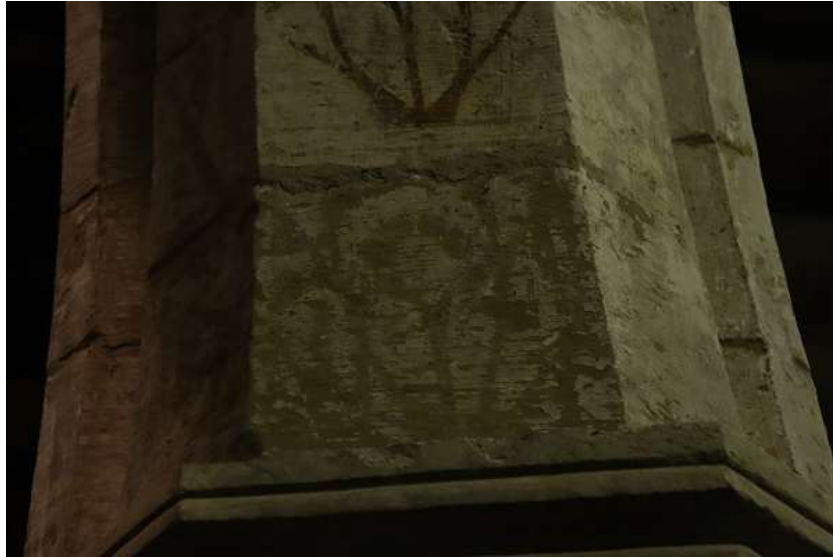
Figure 2 – Preferential flaking of paint on medieval wall painting

The medieval wall painting is only present on the dressed stone of the south arcade arches. The decoration is painted in shades of red and black, and the black appears to be a more fragile pigment than the red. The black fades more than the red, in some places barely visible as a very pale grey, while in other areas it has preferentially stripped away “leaving the formerly black painted areas as patches of yellow stone showing the basic form the decoration against the white ground of the surrounding whitewash” (Fig.2)(Budge 2018 P38).

The paint itself appears to be stable, however there is an ongoing damp problem along the west of the arcade that is resulting in the spalling of the ironstone which if it continues to spread will result in the crumbling away of the stone substrate beneath the paint. (See Section 5.b.2 for more). The paint on the north side of the arcade is more vibrant and less faded than that on the south facing indicating that repeated exposure to the sunlight and UV damage has taken its toll over the years. (See 5.b.1)

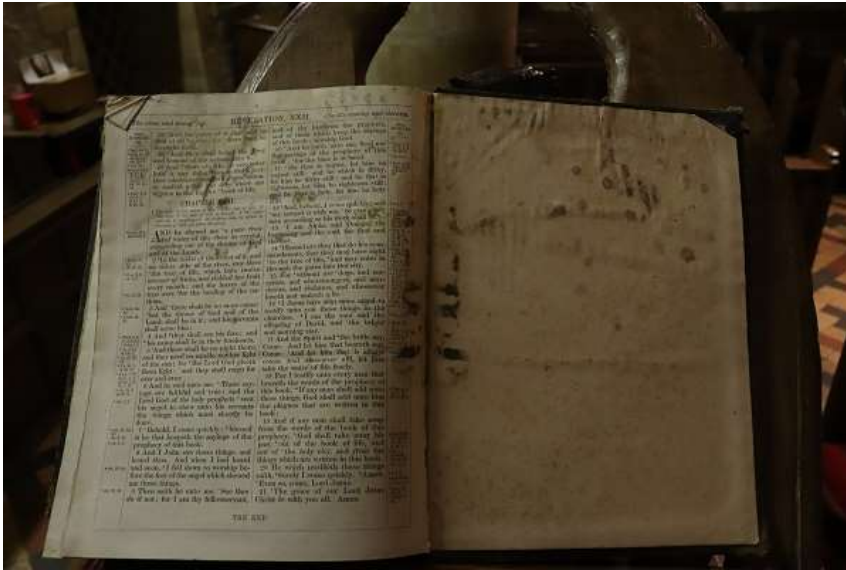
The paper and leather objects of the collection, particularly the leather bound 19<sup>th</sup> bible on the lectern are displaying mould growth on the pages and textile bindings while the leather binding is suffering from mechanical damage from repeated use, brittleness and cracking resulting in loss of some of the spine, as well as fraying and red rot at the headband (Fig.3)(Fig4). This is likely a result of the high RH of the building as well as its storage location on the lectern in front of the south facing windows. (Vandyke-Lee 1979) (5.b.2).

Figure 3 – Mould growth on bible

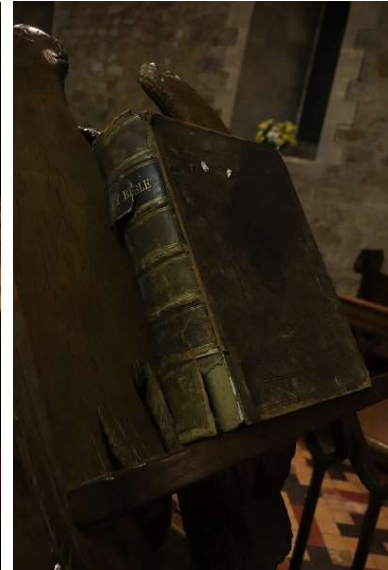
Figure 4 – Damage to leather binding

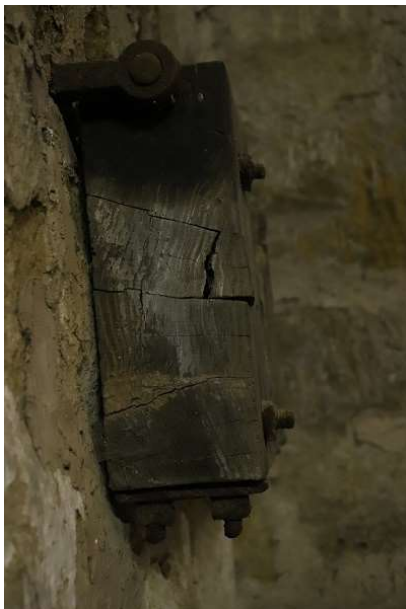
Most of the wooden objects of the collection are all in tolerably good condition considering the high relative humidity (RH) and damp problems within the building. There is past woodworm damage to the 15<sup>th</sup> pews but they are not displaying any current signs of activity. The timber items mounted directly against the west wall do not have a barrier layer between the stone and the objects and have cracked along stress points in places as a result of repeated fluctuations in moisture content (Fig.5) (Ankersmit 2009 P55).

Figure 5 – Crack to wall mounted timber

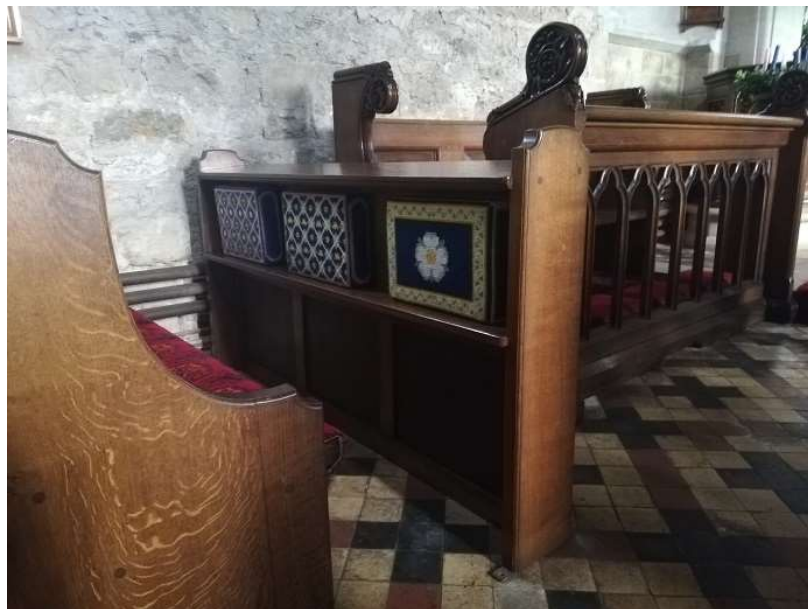
The textiles of the collection are in surprisingly good condition considering the high RH and the mould growth found in the paper collection. They are however working objects within the collection and most likely items such as the altar cloth and vestry curtain are rotated and removed for cleaning by local volunteers on a regular basis. The embroidered kneelers are stored at the back of the pews and as such are afforded some protection from light and moisture damage (Fig.6).

Figure 6 – Storage of embroidered kneelers

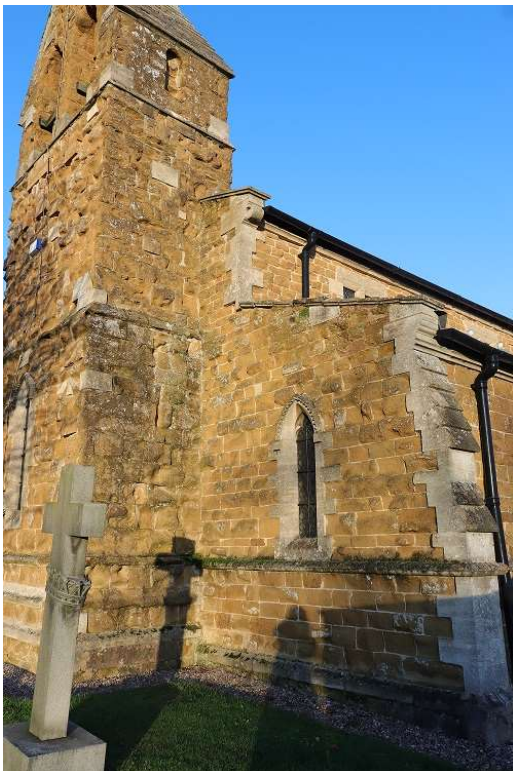
The walls are of ironstone, with dressed limestone window openings, cornerstones and copings. The ironstone is severely weathered and spalling from moisture movement and there are areas of obvious stone repair and replacement (Fig.7). Areas of very extreme spalling are obvious around the belfry, which is believed to be the oldest part of the exterior surviving (W. 2005).

Figure 7 – Spalling to west wall

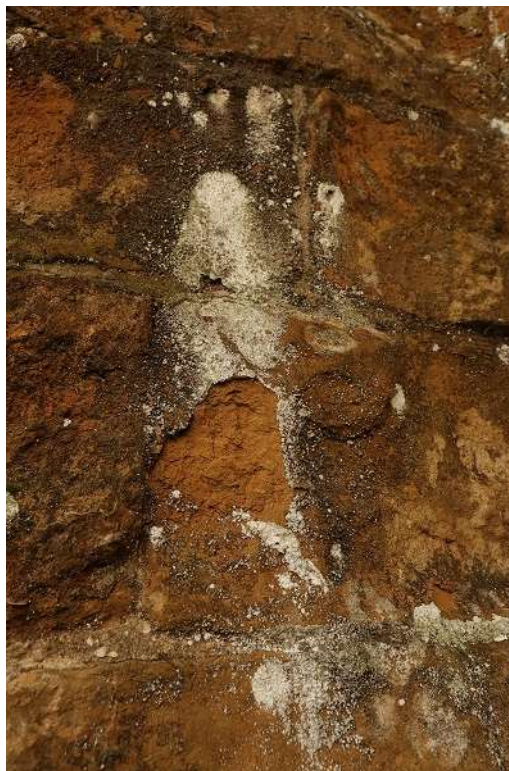
A white efflorescence can be seen in many areas around the exterior, caused by the evaporation of moisture from the stone (Fig.8). As moisture evaporates it causes crystallised salt deposits to be left behind. In cases where the rate of evaporation of the moisture is higher than the supply of moisture, as in the case where there is wind on the exterior of a building, this evaporation will take place beneath the surface of the stone instead of on the surface. The formation of these salt crystals as they dry will cause an increase in volume which results in the crumbling, cracking and spalling of stone. (Ankersmit 2017 p101). Areas where this efflorescence is more abundant on the building include the west walls and belfry, as well as the eastern buttress at the back of the building.

Figure 8 – Efflorescence causing spalling on north wall

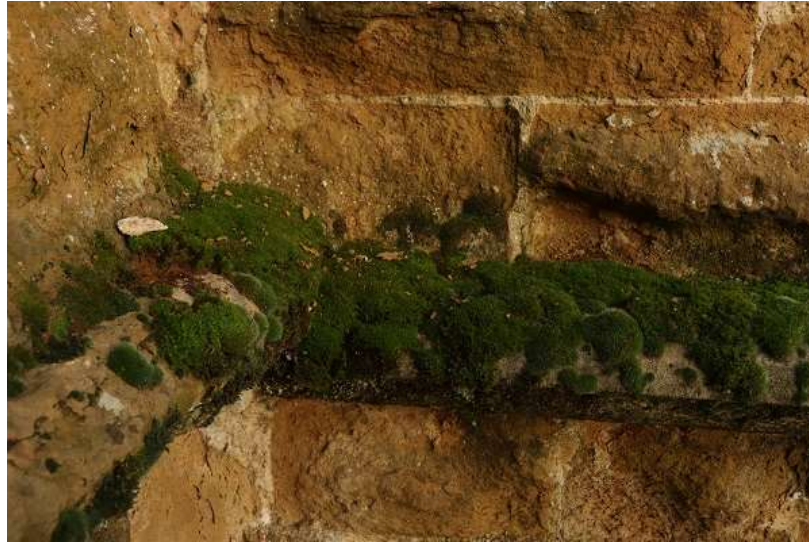
Along the protruding drip course on the west and east of the building there is vibrant moss and lichen growth (Fig.9). This keeps moisture on the surface of the stone, which can cause frost damage through causing spalling and cracking of the stone when the volume of water expands when freezing. Damage from secretion of organic acids is also likely (Watt 2006) (Watt 2004).

Figure 9 – Moss growth on drip course of west wall

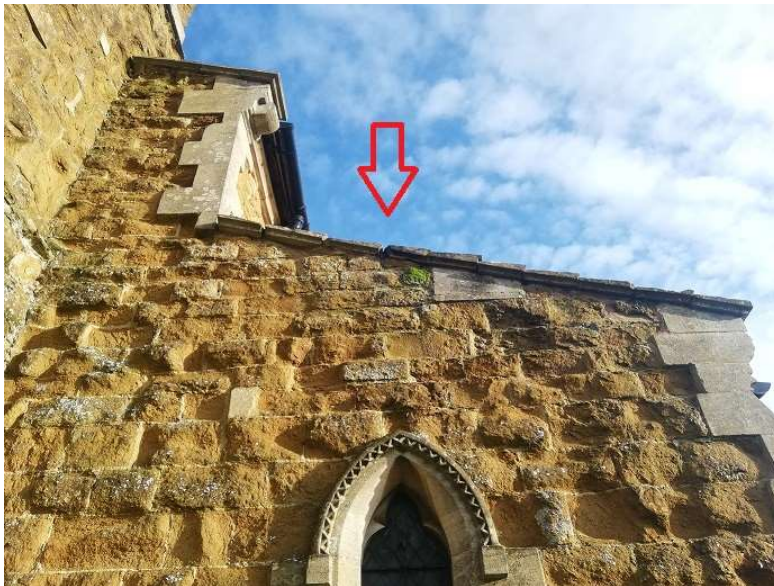
Moss growth can be seen just beneath the coping stones of the western wall indicating a regular presence of moisture to these locations (Fig.10). There is missing mortar between the coping stones above the window, as well as between the belfry wall and the western wall and between the copings stones themselves on the north side (Fig.11). These allow easy access for rainwater to soak directly into the walls of the building. Internally there is evidence of previous water drips from above the window (see section 4.b.1).

Figure 10 – Moss growth and gap in mortar of coping on west wall

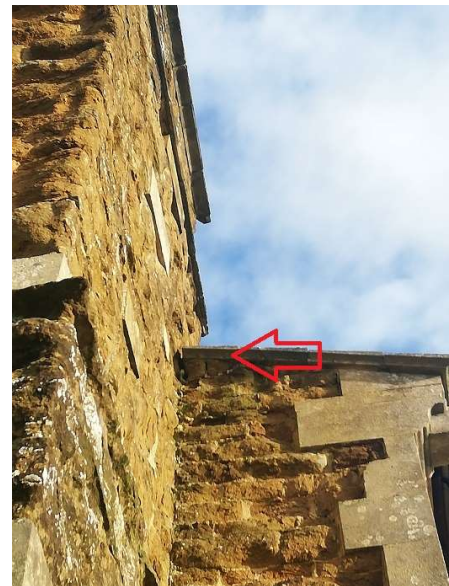
Figure 11 – Gap between coping and belfry

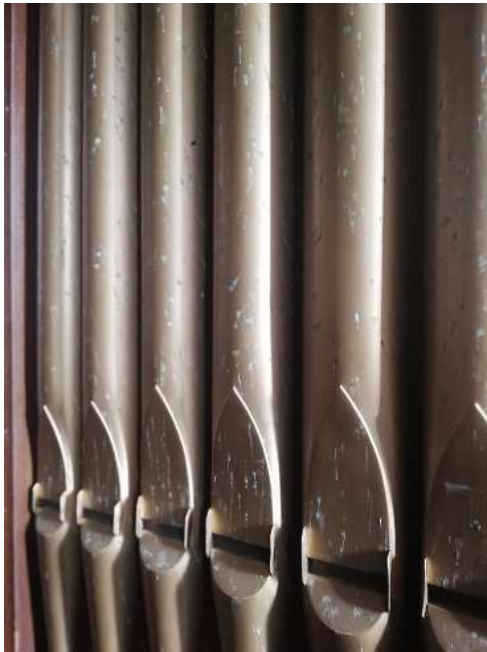
It was only possible to make a visual inspection of the roof from ground level. The roof of the nave, the south aisle and the porch are clad in lead, while the chancel and belfry are slated. In recent years there has been considerable work undertaken to the lead roofs to discover pinhole leaks in the lead flashing, evidence of the damage can be seen internally where white mould has bloomed in the effected roof rafters. (W. 2005, p14). Internally there is considerable evidence of water dripping from above on metal items; organ pipes, memorial brass plaques and the brass monument, while there are discoloured areas of dripping on the west wall. It is unclear whether the majority of these occurred before the roof repair or more recently (Fig.12 & 13).

Figure 12 – Drip marks on organ pipes

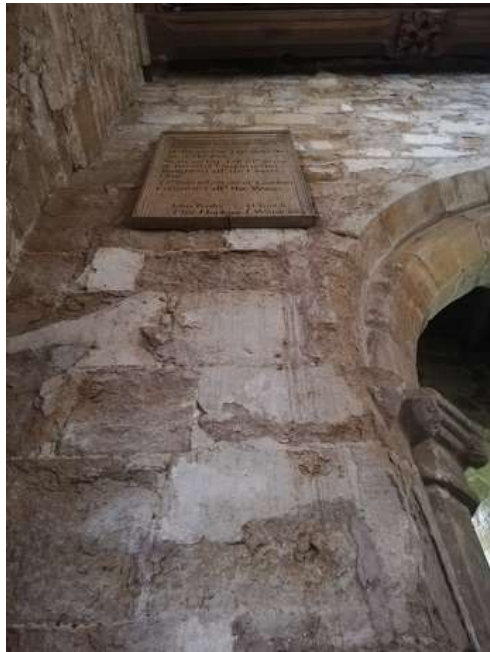
Figure 13 – Drip marks on west wall

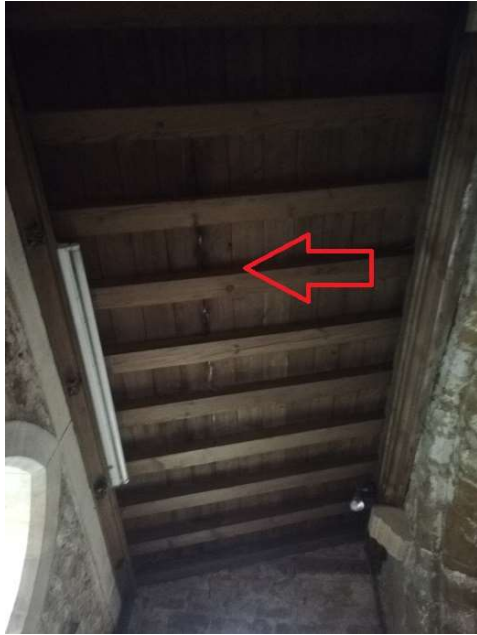
On the last visit to the building there was fresh dashed droplets of water from above obvious on the glass of the framed print inside the door. There was a dark patch, as well as white mould between the boards on the interior ceiling which may indicate a new pinhole leak to the south aisle lead roof. There had been rain the previous evening (Fig.14) (Fig.15).

Figure 14 – Darkening between ceiling timbers

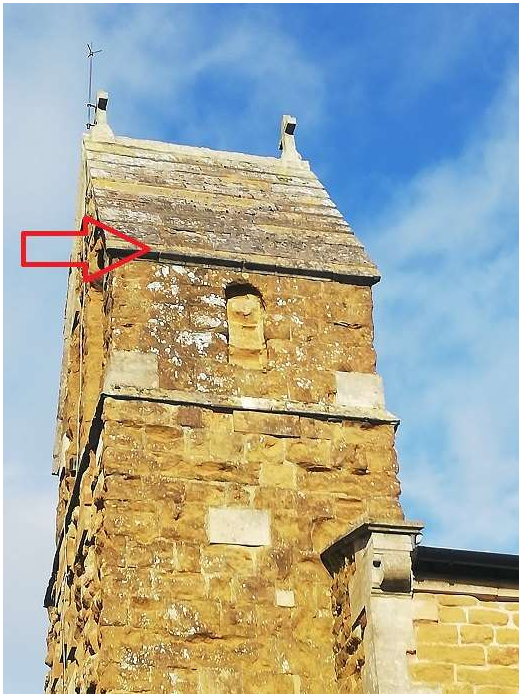
There appears to be either a missing or possibly shattered slate on the south side of the belfry roof, unaided visual inspection from ground level was not very clear. Beneath this there appears to be a darkening of the stone and a patch of efflorescence visible, which if not just a trick of the eye would indicate rainwater is soaking into the building here (Fig,16). The shaded north side of the belfry roof displays an impressive growth of moss across the slates which can cause damage as described in 4.a.1, but which could also be concealing other cracked or damaged slates here also (Fig.17).

Figure 16 – Missing slate on south side of belfry roof

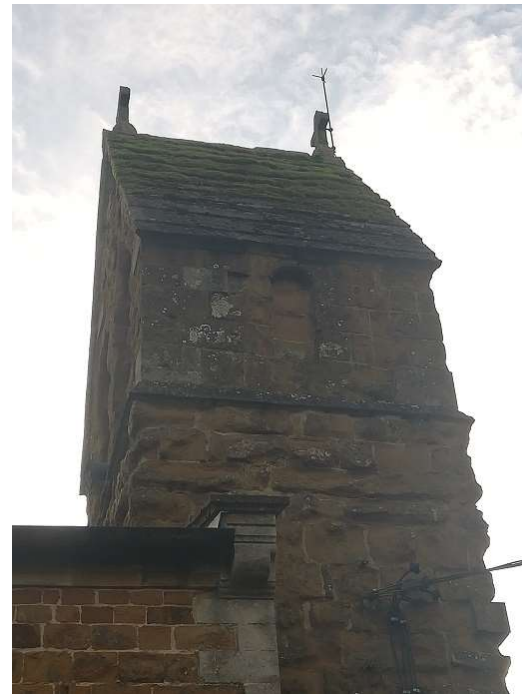
Figure 17 – Moss growth on north side of belfry roof

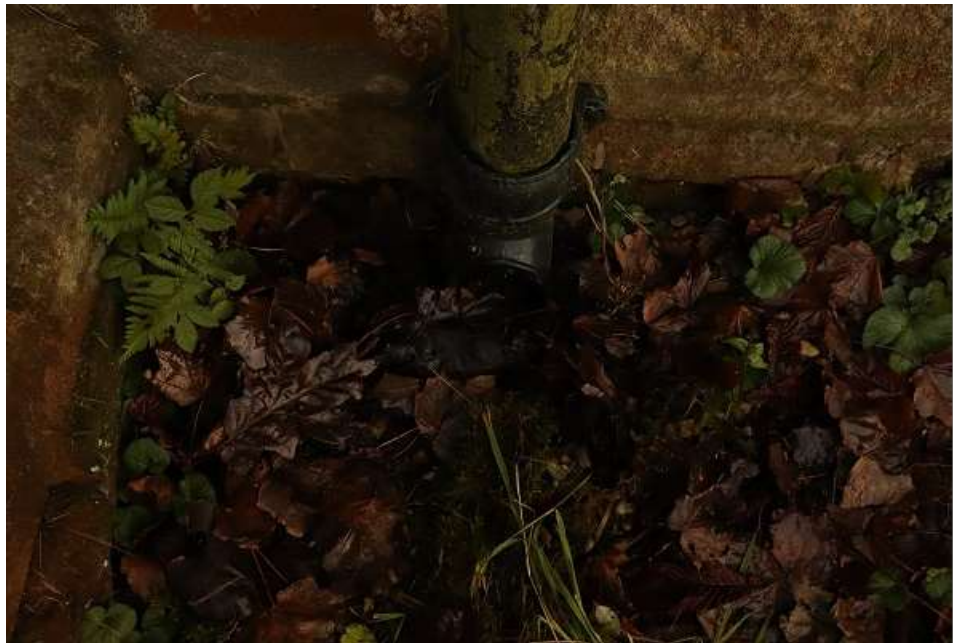
At the front of the building the drain is kept in perfect condition, free of debris and vegetation, however the drain at the back has a build-up of recently fallen leaves covering most of the gravel drain and plant growth has started in the gravel also, particularly by the eastern buttress beside the chancel (Fig.19). These both keep moisture against the back wall counteracting the purpose of the drain. The gully grates under the downpipes here were covered with the autumn leaves also making it more likely for water to pool in this area (Fig.18).

Figure 18 – Leaves and vegetation blocking drain gully

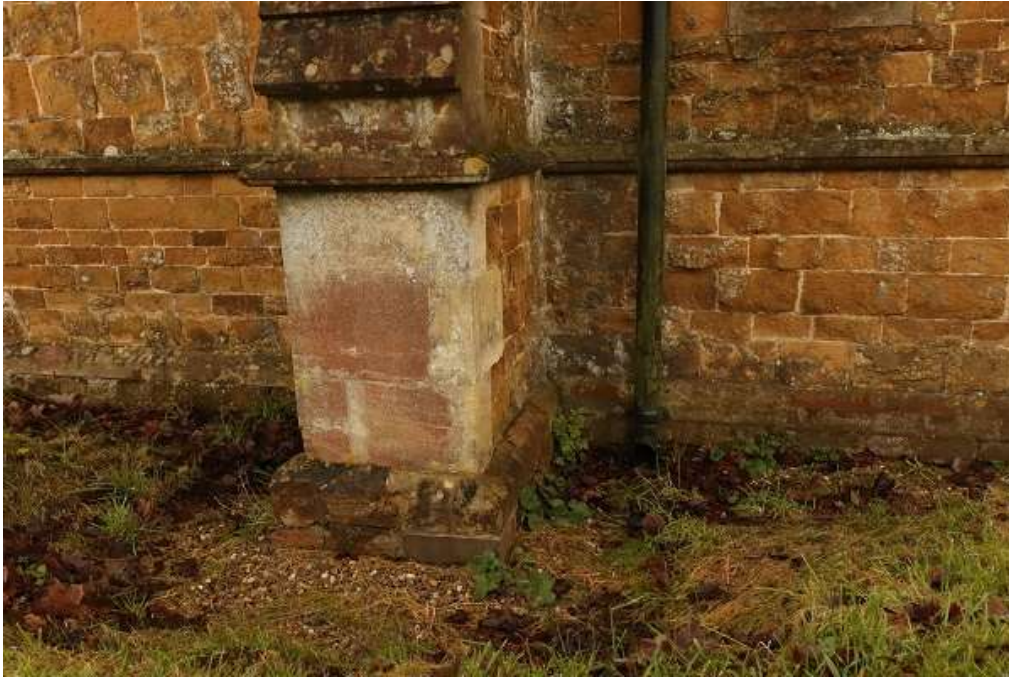
Figure 19 – Vegetation growth in frenchdrain at rear of church

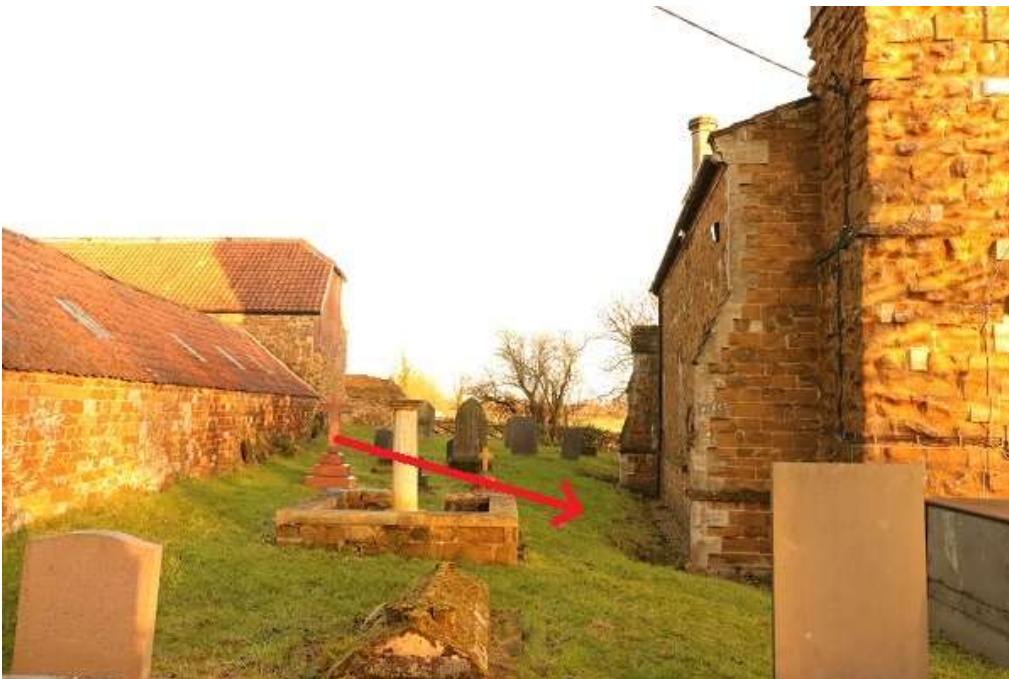
As the building is positioned down from a slope, the groundwater that will accumulate at the back walls will be higher; groundwater from the slope will all be flowing down towards the church wall (Fig.20). The frenchdrain in this part of the building is particularly useful and should be kept clear to allow best functioning.

Figure 20 – Sloping of ground to the rear of the church

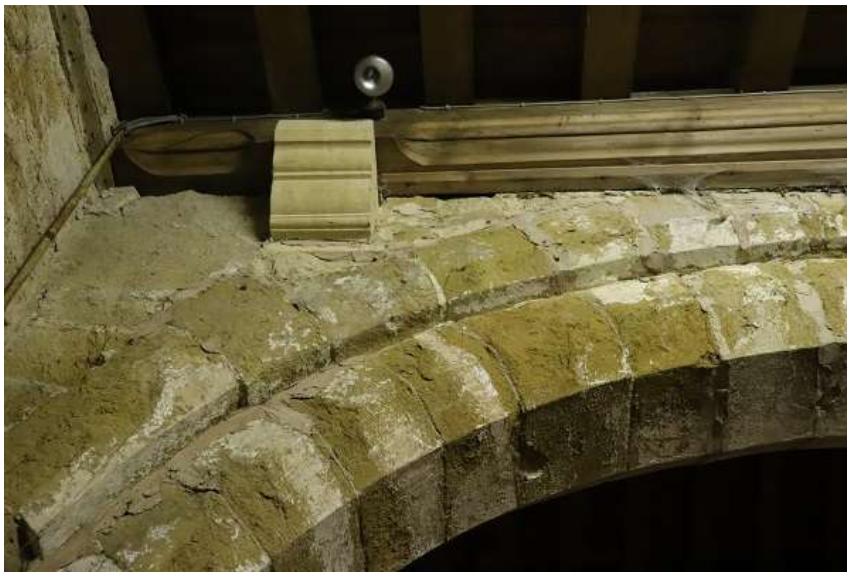
The interior walls are bare rough-cut stonework in most places with dressed stone around the window, door and arch openings likely inserted during the renovations in 1867. There is significant spalling of the ironstone throughout the interior of the church, most likely due to many years of moisture migration and evaporation through the soft stone. (see 4a.1). Areas of particularly severe spalling include the entirety of the walls of the Belfry from the base to the top, the adjoining western wall, and the top of the arches of the aisle. Particularly worrying is the spalling that is present on the west arch as should it continue to spread the medieval wall painting remnants will crumble away also (Fig.21) (Fig.22).

Figure 21 – Spalling of stone of west arch

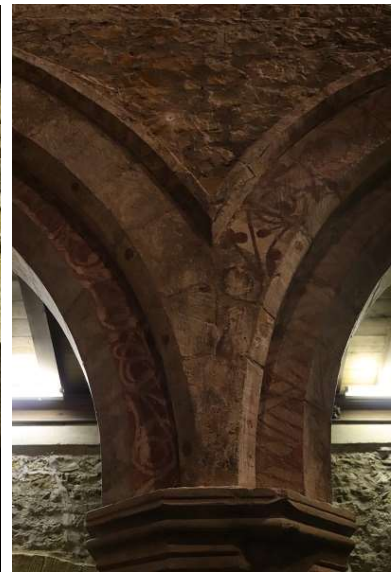
Figure 22 – Medieval wall painting

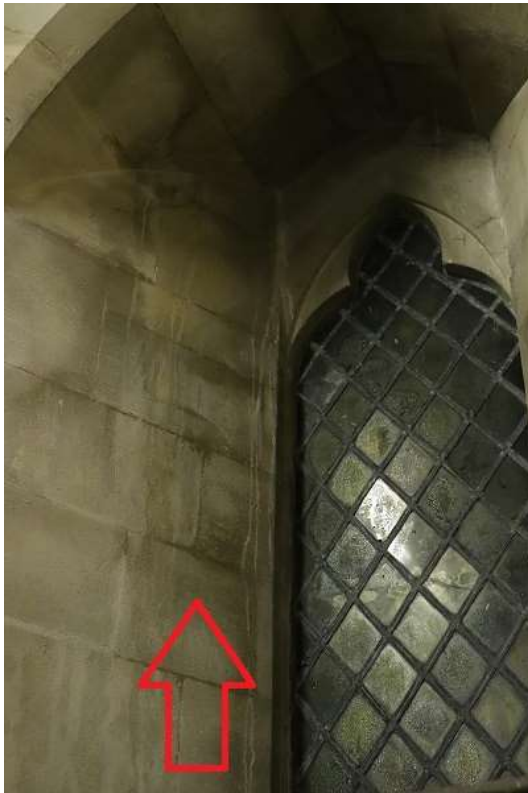
Moisture readings of the west wall and the belfry however show high moisture content in the stone from the base of the wall up to 2metres. WME : 45 – 55% (Hindle 2019). The walls within the Belfry retain traces of many layers of paint or limewash over which a green mould thrives and active spalling of the stonework is evident in the dust and crumbled stone visible on the floor. There are tide marks in the base of the pillars of the belfry and the westernmost of the south aisle (Fig.24). As mentioned in 4.a.1, there are drip marks and cracks in the stonework above the west window of the south aisle (Fig.23).

Figure 23 – Dripmarks on west window

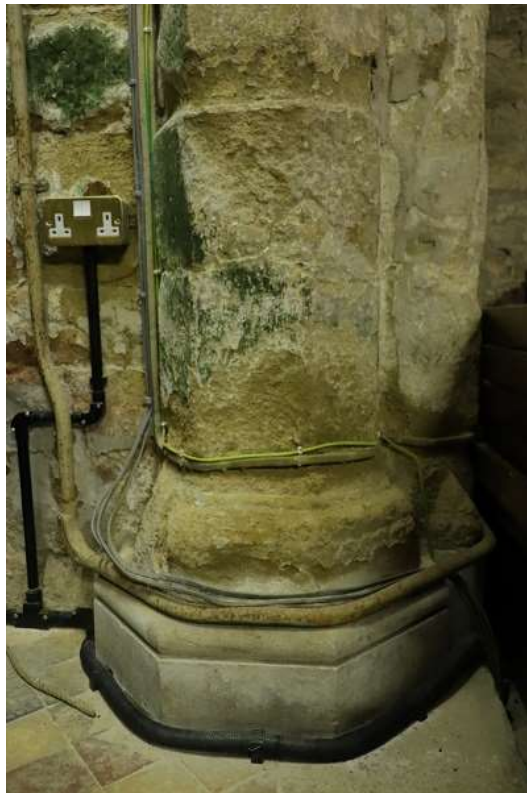
Figure 24 – Tidemarks and spalling of west pillar

These serious moisture issues could be the accumulated result of a number of colluding factors on the exterior: the missing/damaged slate on the belfry roof, the gaps between the coping stones, the accumulated moss growth on the drip course, and vegetation debris in the frenchdrain. Drip marks on the stonework and brass plaques of the adjacent nave wall also suggest possible faults in the flashings of the nave roof where it meets the belfry.

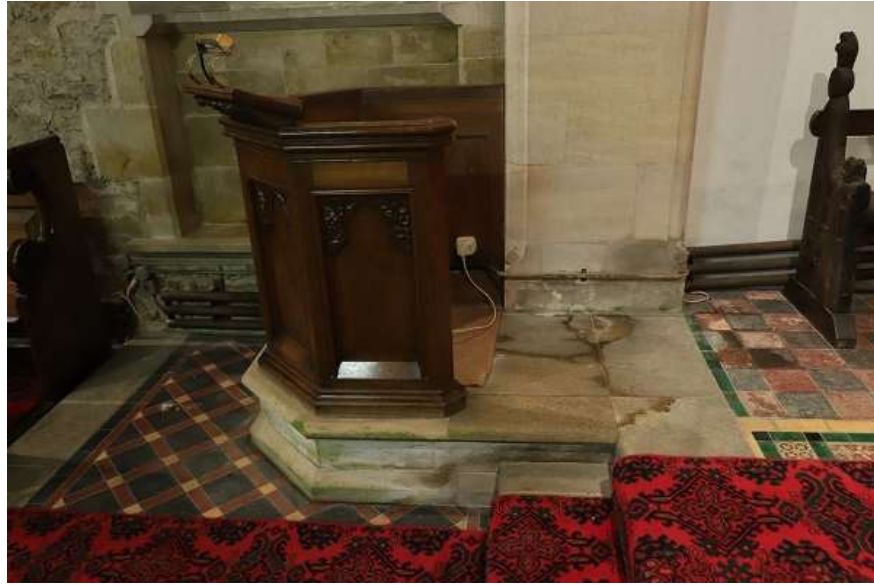
There are significant tidemarks as well as areas of green mould surrounding and beneath the pulpit (Fig.25). Further examination with a moisture reader confirmed dampness in these areas and in the plaster in the east wall of the chancel behind. The frenchdrains and gully to the exterior of this area are also clogged with vegetation debris and growing plants (Fig.26). The presence of the two blocked gulleys in this area and the moisture reading suggest the debris may be the cause of the dampness here.

Figure 25 – Tidemarks and green mould at base of pulpit

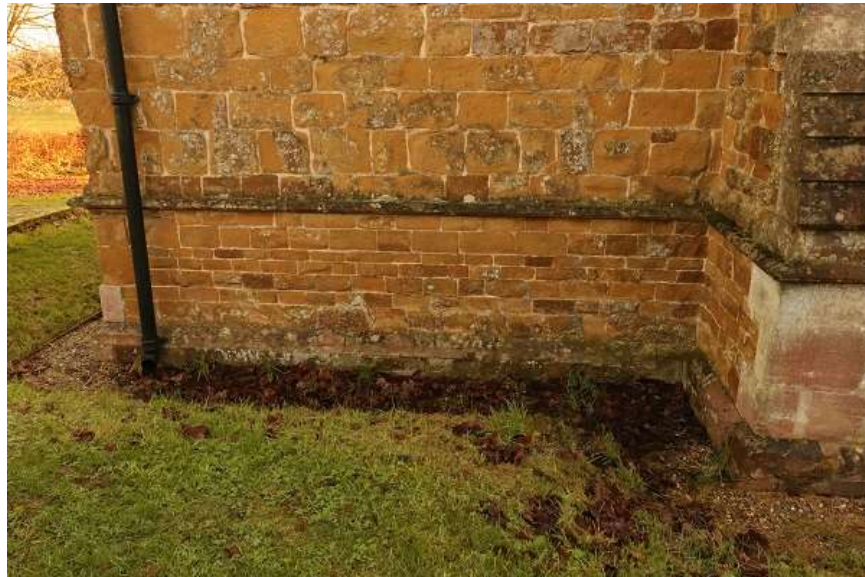
Figure 26 – Leaves blocking the french drain and gully at rear of chancel

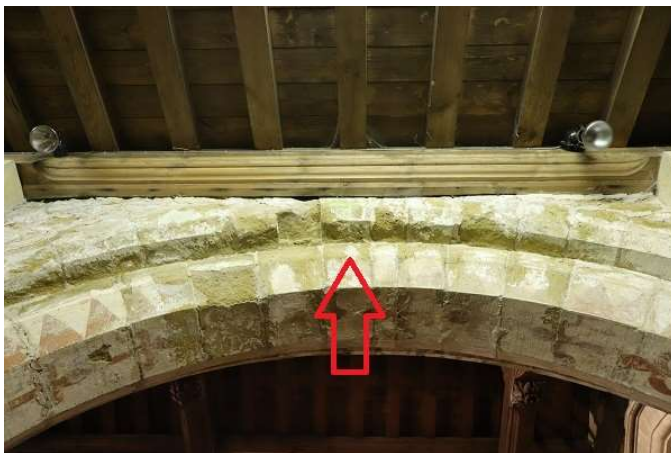
As discussed in 4.a.2, there are many residues of splash marks on the metalwork objects in the building as well as drip marks on the stonework of the west wall. Some of these could have been caused during the previous leaks or from condensation. There is however a small area of green mould growing on the stone above the eastern arch of the south arcade (Fig.27) adjacent to the splash marked organ pipes which suggests consistent moisture in the area currently.

Figure 27 – Green mould growth above easternmost arch

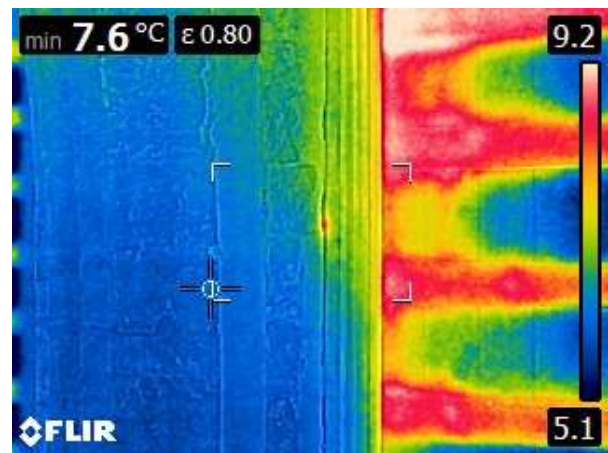
Figure 28 - IR Thermometer reading of westernmost arch

When reviewed with a FLIR® TG165 IR Thermometer at sunset on a sunny day a small area of heat can be seen between the stone and the sun heated timber beams under the lead possibly indicating a thermal bridge of moisture and a new pinhole leak (Fig.28).

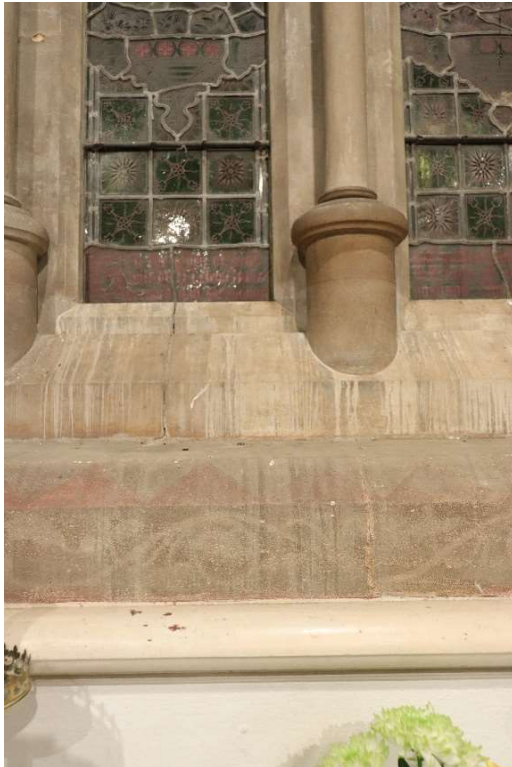
There are considerable drip stains on the stonework beneath the stained glass in the chancel (Fig.29) and during one survey water was seen to seep in from the lead comes of the central light (Fig.30), there was light rain outside. There is a cracked pane currently repaired with a clear adhesive tape. And a slight bow in the stained glass and the west chancel leadlights that appear stable currently but may need attention in the near future.

Figure 29 – Drip marks on stone and residue paint.

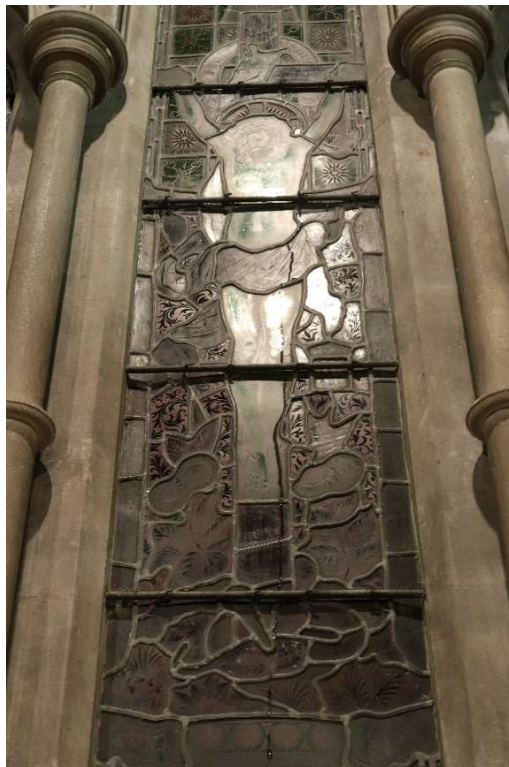
Figure 30 – Drip on central stained glass window

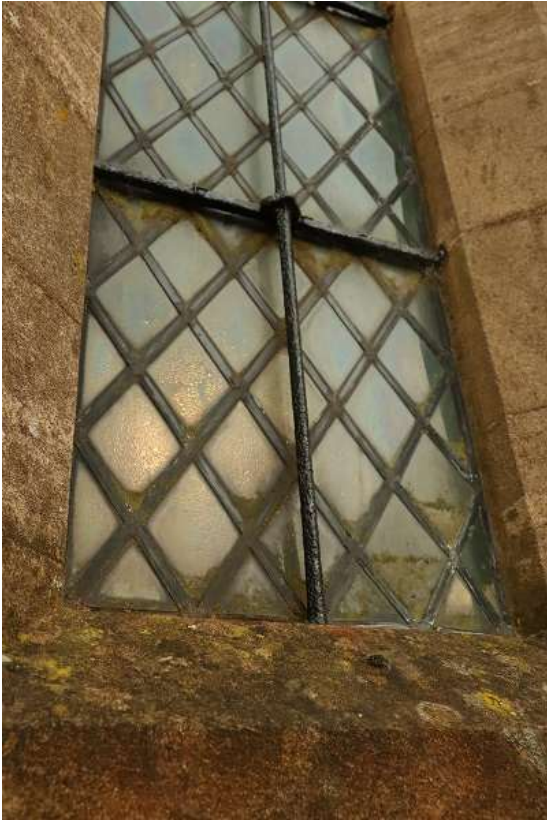
The rest of the windows appear in good condition with no evidence of leaks despite two or three cracked panes. There is a build-up of dirt and encrustations on the exterior of the clear quarries that will aid the corrosion of the glass (Fig.31). There is already an iridescence weathering crust on the exterior indicating active corrosion (Fig.32) (Romich, 2004) (Van Giffen, 2014).

Figure 31 – Encrustations on window exterior

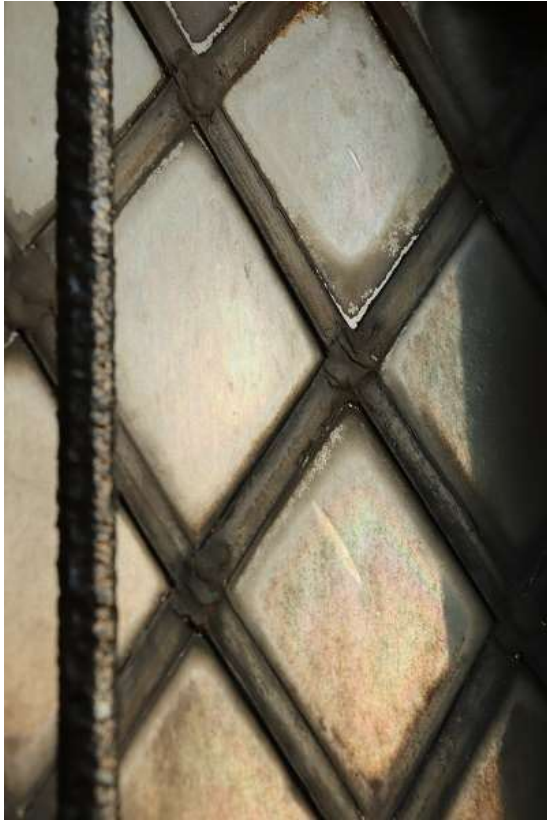
Figure 32 – Irridescence on glass exterior

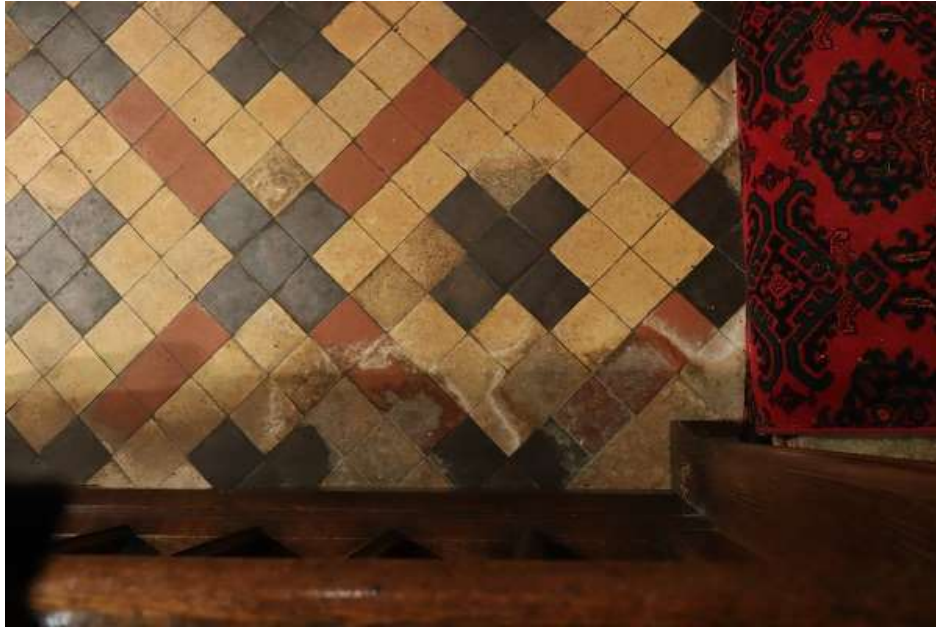
Figure 33 – Efflorescence on floor tiles

There is salt efflorescence evident in the floor tiles of the nave, particularly around the edges of and beneath the pews. There is also the previously mentioned tidemarks and green mould growth at the base of the pulpit. As discussed in 4.b.1 this is likely a result of the build-up of vegetation in the drains to the exterior of these walls. In the below image displaying the moisture readings of the pulpit floor however it is possible to see how this excess water is moving through the stone of the floor and the tiles.

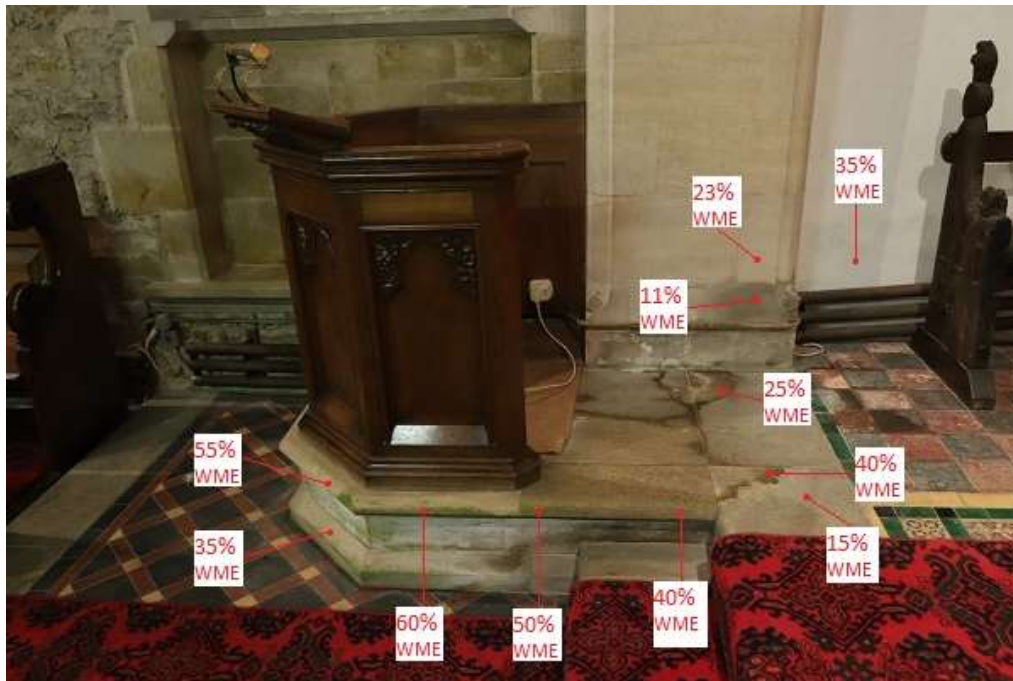
Figure 34 – GE Protimeter Mini© readings along tidemarks at base of pulpit

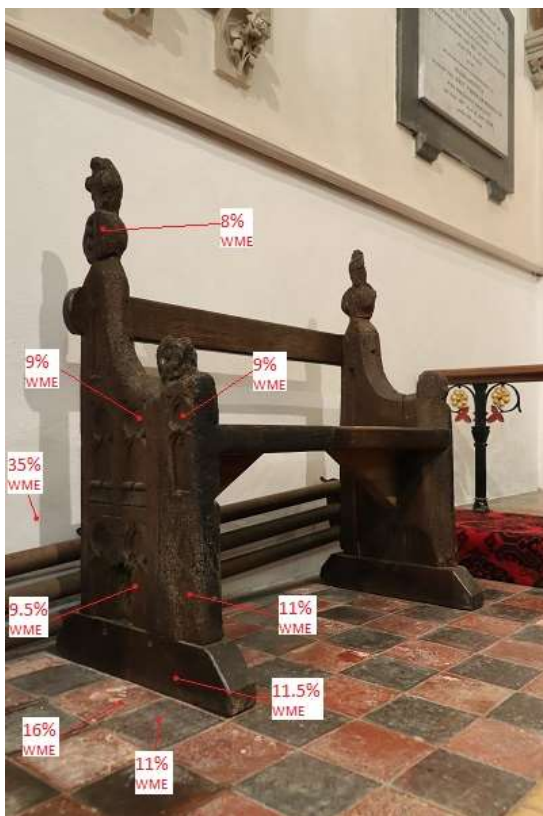
Moisture and IR thermometer readings taken of the 15<sup>th</sup> pew and the floor tiles beneath it show that a certain amount of moisture is rising up through the timber from the floor. The adjacent plaster also displays a high moisture reading for its material. (Hindle, 2019)

Figure 35 - GE Protimeter Mini© readings of pew

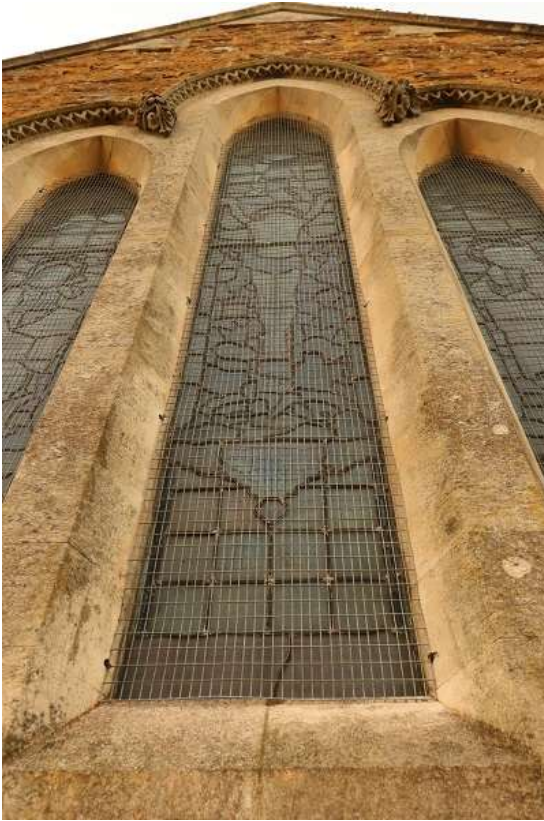
Figure 38 – Metal grille over stained glass window

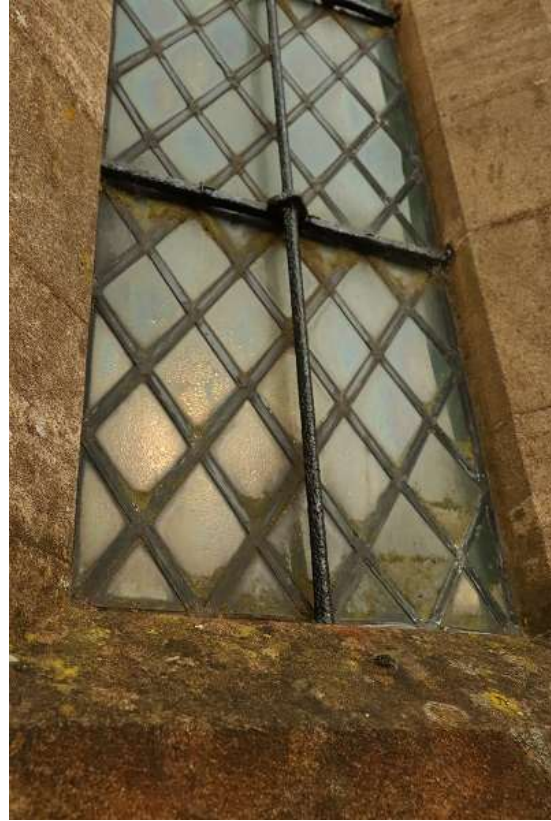
Figure 39 – Iron bar on south window

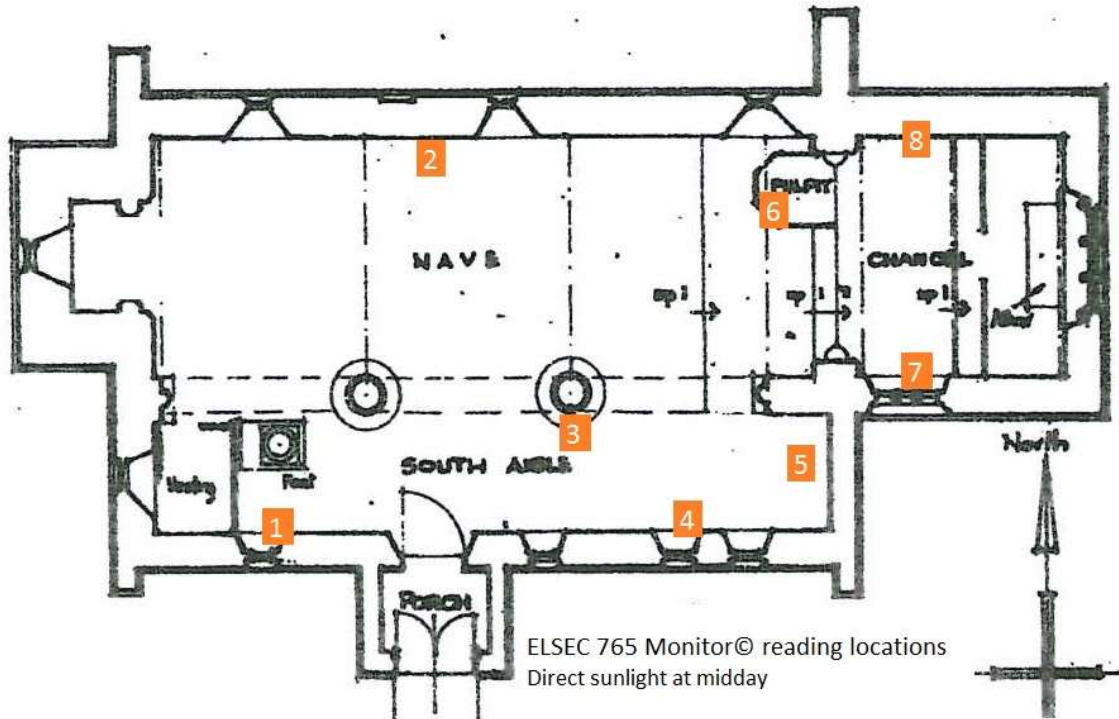
Location	$\mu\text{W} / \text{lumen}$	Lux
1 In front of south window	43	4057
2 North wall Nave	24	1475
3 On pillar below capitol	48	2184
4 In front of south window	106	2358
5 On organ pipes	61	987
6 On pulpit	51.5	322
7 In front of south window	25	1501
8 North wall Chancel	24	1475

Figure 40 – Floor plan showing ELSEC 765 Monitor® direct sunlight readings

Reviewing the readings it is obvious the lux levels in direct sunlight are far beyond recommended levels (Fig.40) and make it very apparent why the wall paintings have survived better on the north face of the south arcade. The levels in indirect sunlight are far more moderate and almost all fell within recommended levels excepting objects in close proximity to south facing windows (Fig.41). The incandescent and fluorescent lighting of the church also falls within recommended levels (Fig.42).

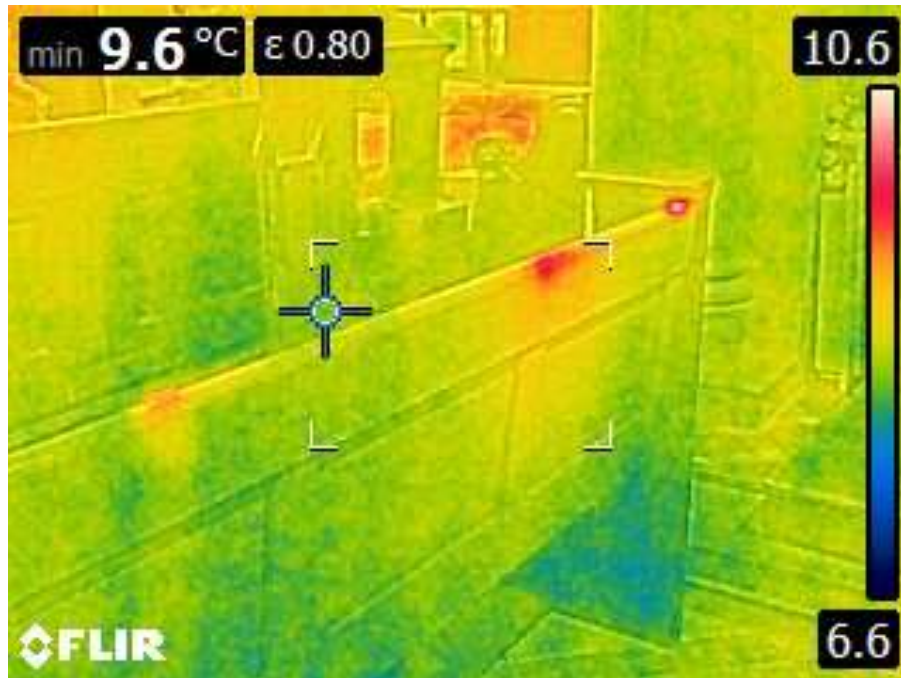
Figure 46 - Flir® TG165 IR Thermometer reading solar gain on wooden pews

Such fluctuations where direct sunlight is passing over the wall painting are particularly worrying. There is already evidence of salt efflorescence in the stonework of the building (detailed in 4.a.1 and 4.b.1). Fluctuations in the RH can “activate moisture transfer between the wall and the internal atmosphere causing soluble salt crystallisation cycles” (Henry & Stewart, 2011 p498) which can cause spalling of the stone surface and as such, loss of the painting.

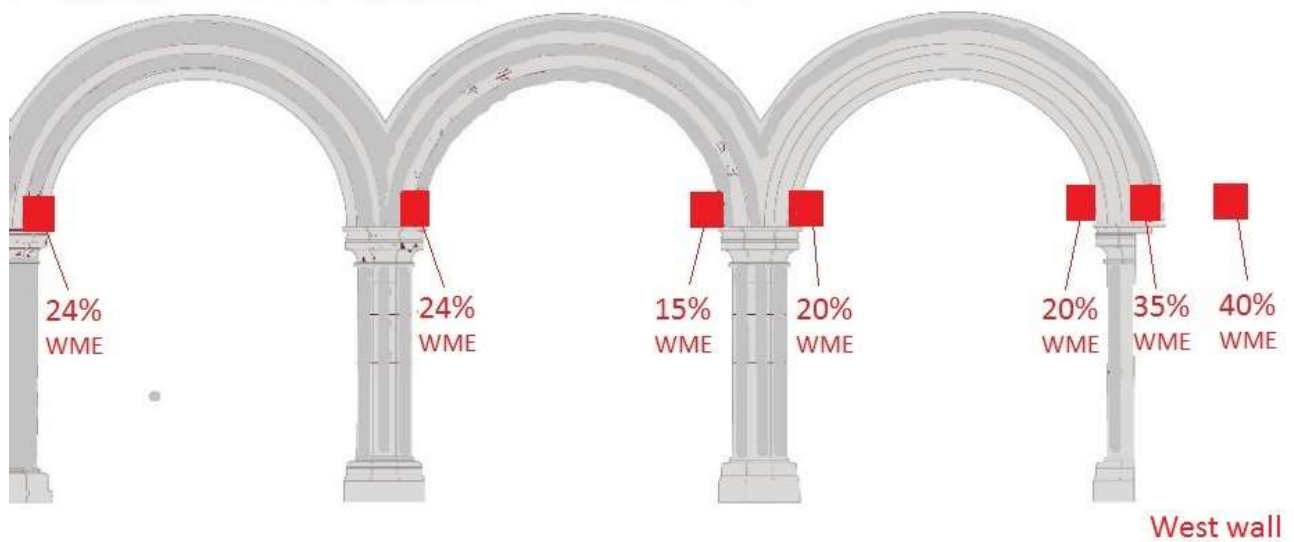
The below interpretation of the south arcade as viewed from the Nave shows readings displaying the increased moisture content of the westernmost pillar adjacent to the west wall and a slightly higher content in the easternmost arch beneath the area of green mould mentioned in 4.b.2. giving an indication of how moisture may be moving through the arches (Fig.50).

Figure 50 – Elevation drawing of south arcade showing Protimeter Mini© moisture readings (Budge 2018)
