# Building and Collection Survey

Leicestershire Church

November 2019

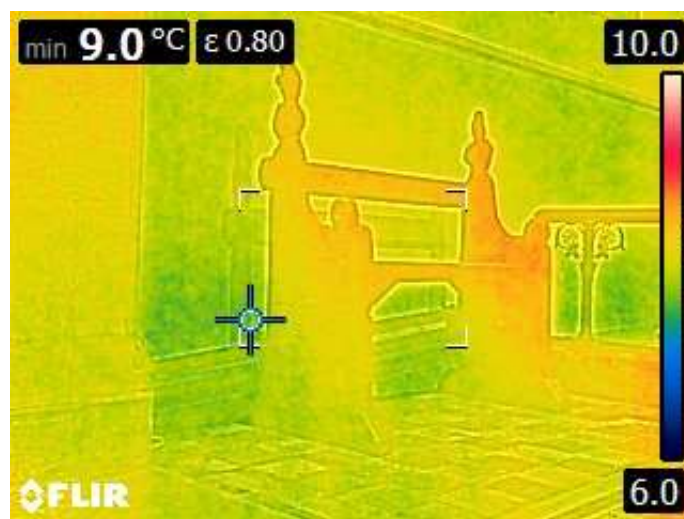
Figure 36 - Flir® TG165 IR Thermometer reading of pe

The most drastic of these instances was on 09.12.2019 when RH dropped by 15% to 69.5% about midday and temperature increased by 4.5°C to 12°C. The image below displays the residual heat retained in a wooden pew an hour after direct sunlight had shone through the three south facing lancet windows at sunset on the 29<sup>th</sup> November (Fig.41).

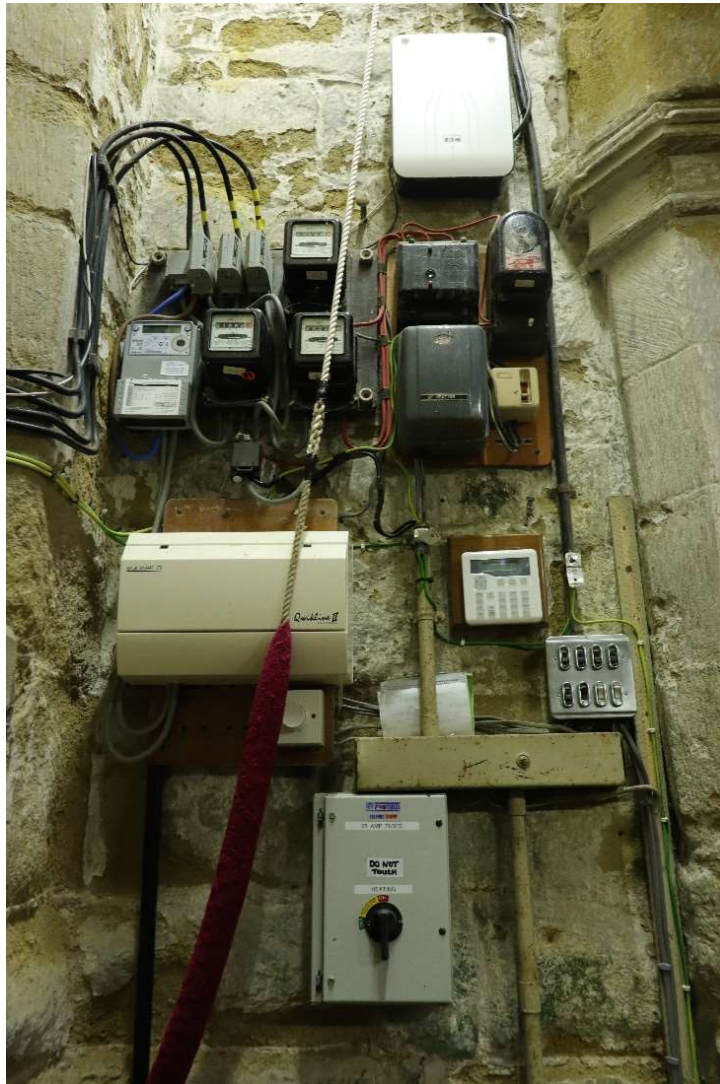
Figure 37 – Mains services in belfry

Electric light was first used in the church in 1947 and was rewired in 1990 by a locally resident electrician. Indirect incandescent downlights were added at this time to the nave and chancel and are noted to have ‘greatly improved the internal appearance of the church’. (W. 2005) (Further discussion in 5.b.1 about their effect on the collection).

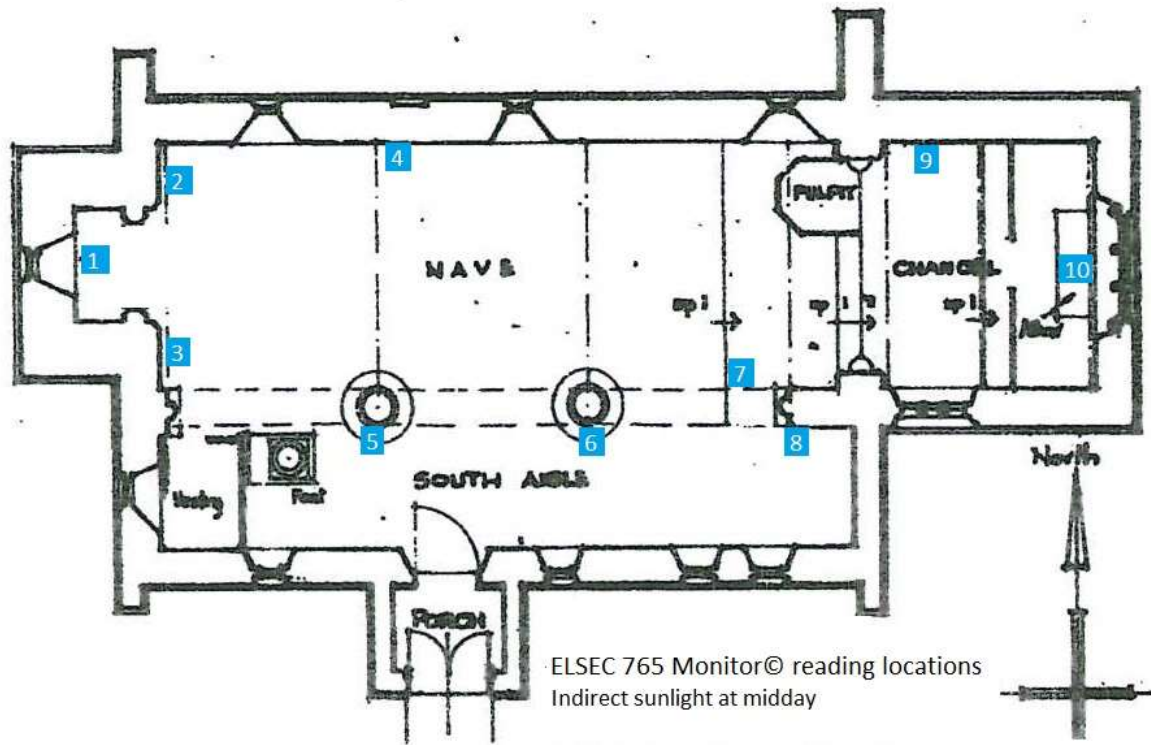
Figure 41 – Floorplan showing ELSEC 765 Monitor© indirect sunlight readings

Reviewing the readings it is obvious the lux levels in direct sunlight are far beyond recommended levels (Fig.40) and make it very apparent why the wall paintings have survived better on the north face of the south arcade. The levels in indirect sunlight are far more moderate and almost all fell within recommended levels excepting objects in close proximity to south facing windows (Fig.41). The incandescent and fluorescent lighting of the church also falls within recommended levels (Fig.42).

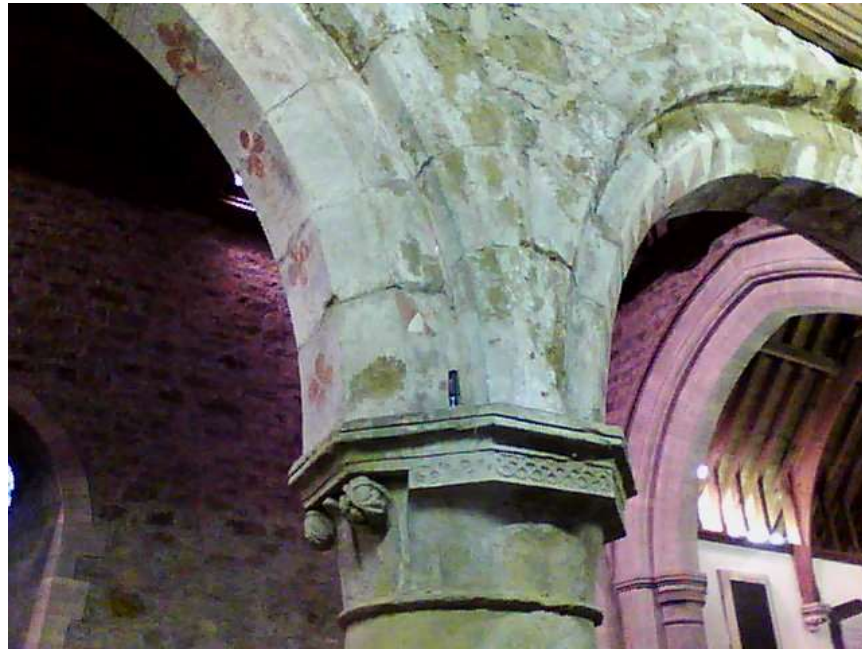
Figure 43 – Datalogger© positioned above capitol in front of painting

The Datalogger© recording the relative humidity (%RH) and temperature (°C) at 5-minute intervals was positioned above the capitol of one of the south arcade arches in front of the medieval painted decoration and recorded for 19 days.

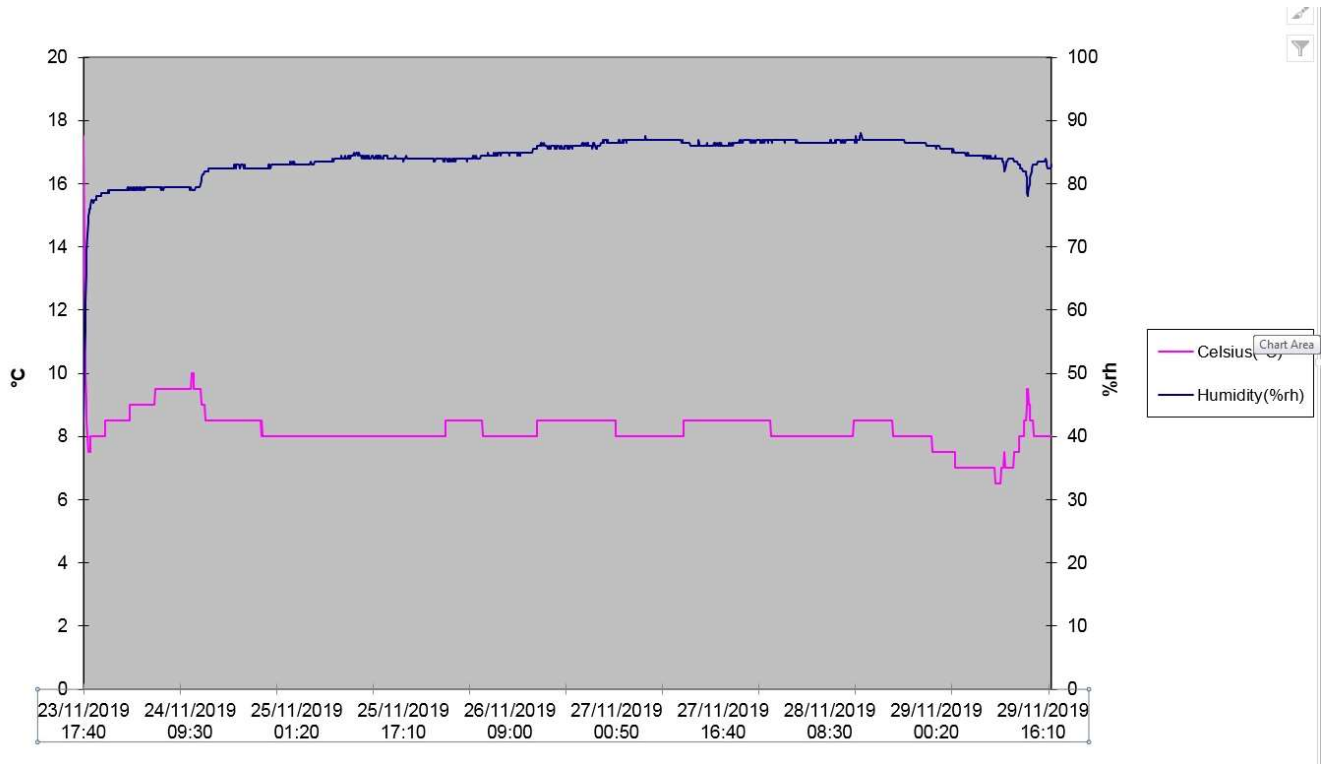
– Graph displaying results of Datalogger© 23.11.2019 - 29.11.2019

The external RH during this time ranged from 70 – 100% with an average of 99% while external temperatures ranged from -3 – 12°C with an average of 6°C. (Customweather© , 2019) Within the building the RH generally ranged from 76 - 93% with an average of 85% while temperatures generally ranged from 5.5 - 8.5°C with an average of 7°C showing that the building provided some insulation against the outside conditions.

There were repetitive lower peaks of RH and higher peaks of temperature recorded outside of these ranges (Fig.44 & 45) These occurred only on clear days and are likely the result of solar gain when direct sunlight fell across or close to the meter around midday.

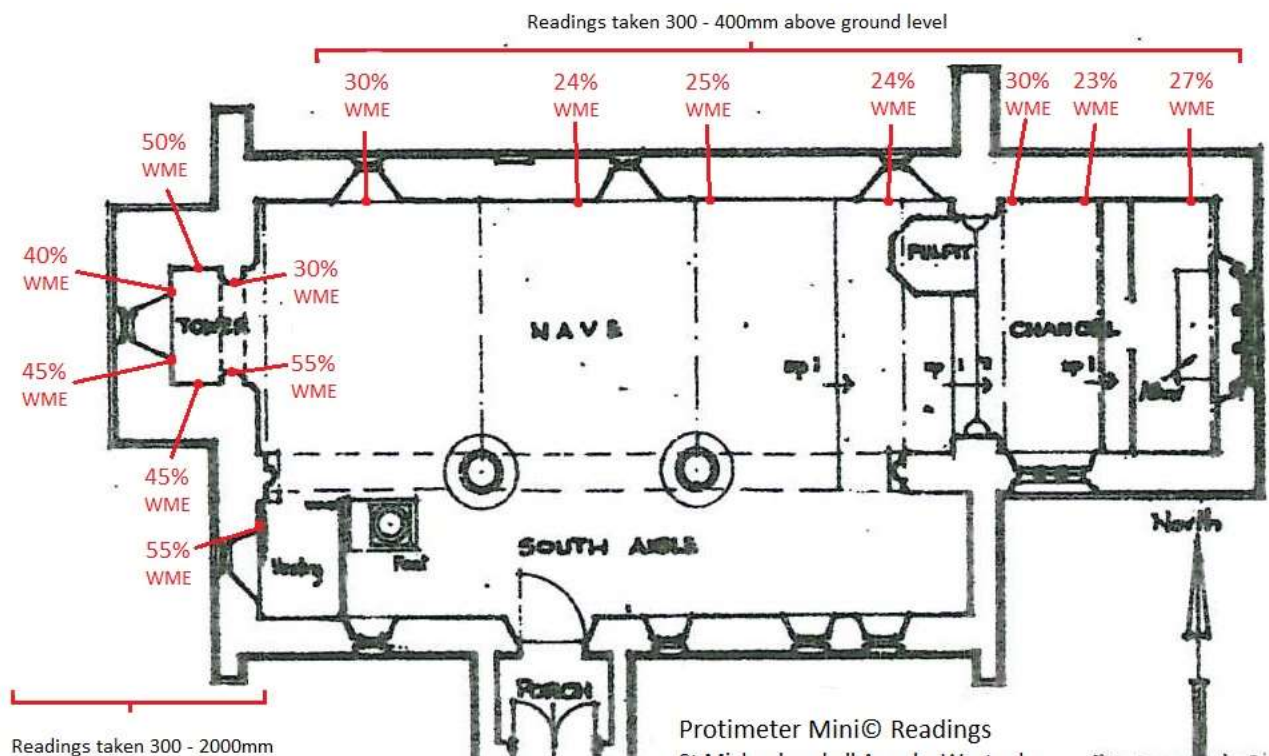
Figure 47 – Floorplan showing Protimeter Mini© Readings

Also worth taking into consideration while reviewing the data is that the presence of salts, which are evident in the efflorescence visible throughout the building can often cause electric moisture meters to over-read moisture levels (York Survey Supply Centre 2019).

As such these moisture readings should not be taken as guaranteed indications of actual moisture content by themselves unless used in conjunction with other methods of interpretation such as an IR Thermometer in 4.b.4. Below they are used in conjunction with a map of the RH% and temperature to show the elevated moisture levels along the western wall in comparison to the north wall, as well as a slightly higher elevation of moisture on the plastered north wall of the chancel confirming the visual interpretations in 4.a.1 and 4.b.2.
